## Baseline Assessment – Stream Attributes

**Reach S-Q2 (Timber Mat Crossing)**

**Pittsylvania County, Virginia**

Project #	Project Name (Applicant)	Locality	Cowardin Class.	HUC	Date	SAR #	Impact Length	Impact Factor
22865.06	Mountain Valley Pipeline (Mountain Valley Pipeline, LLC)	Pittsylvania	R3	03010105	8-19-21	S-Q2	20	1
Name(s) of Evaluator(s)		Stream Name and Information					SAR Length	
SK, VM		UNT to Pole Bridge Branch					114

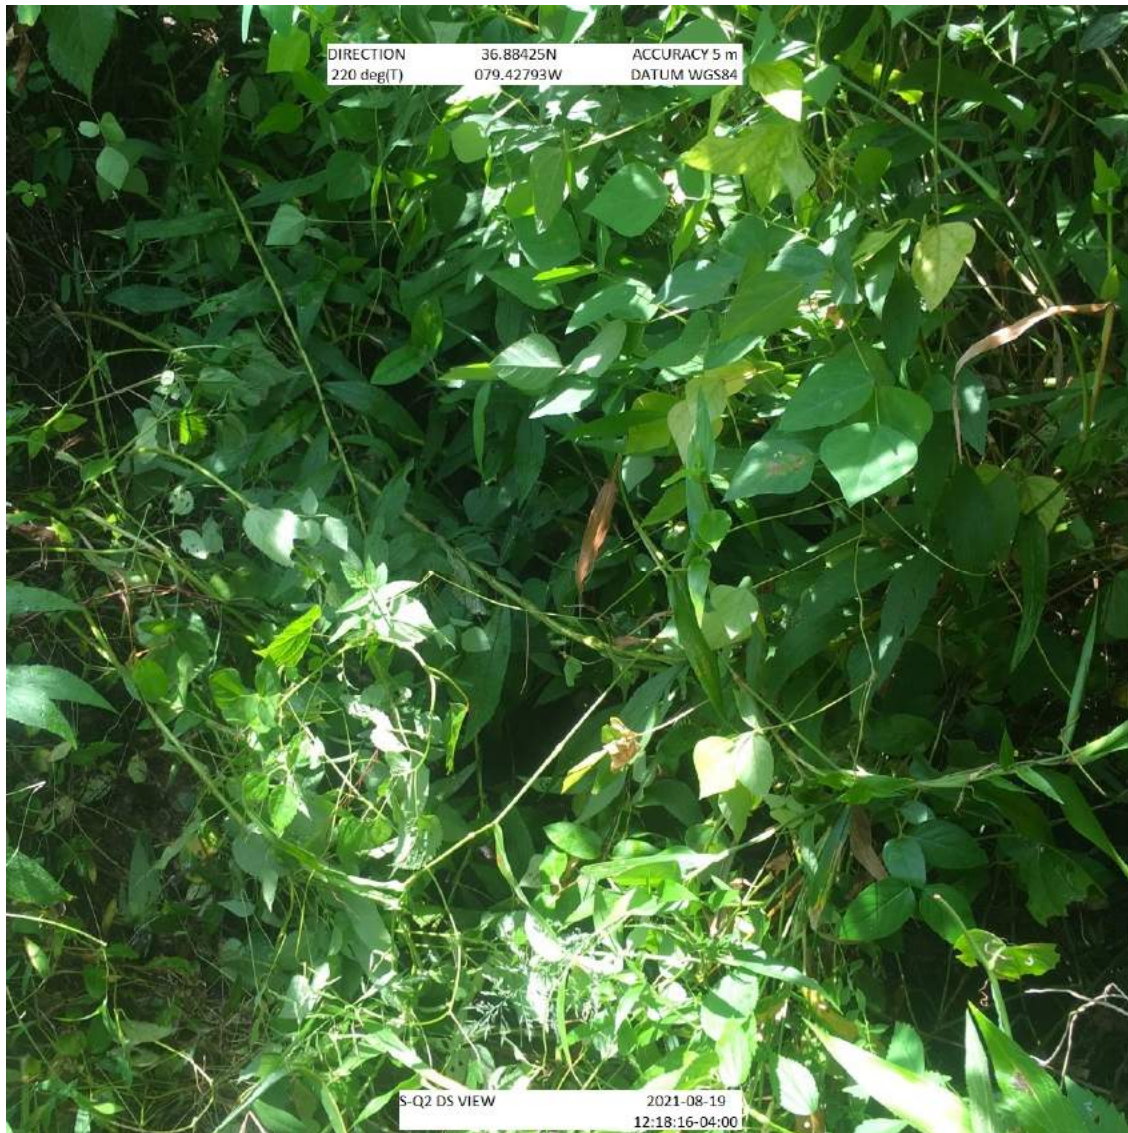
Photo Type: DS VIEW

Location, Orientation, Photographer Initials: Downstream view of ROW looking NE, CB/BH

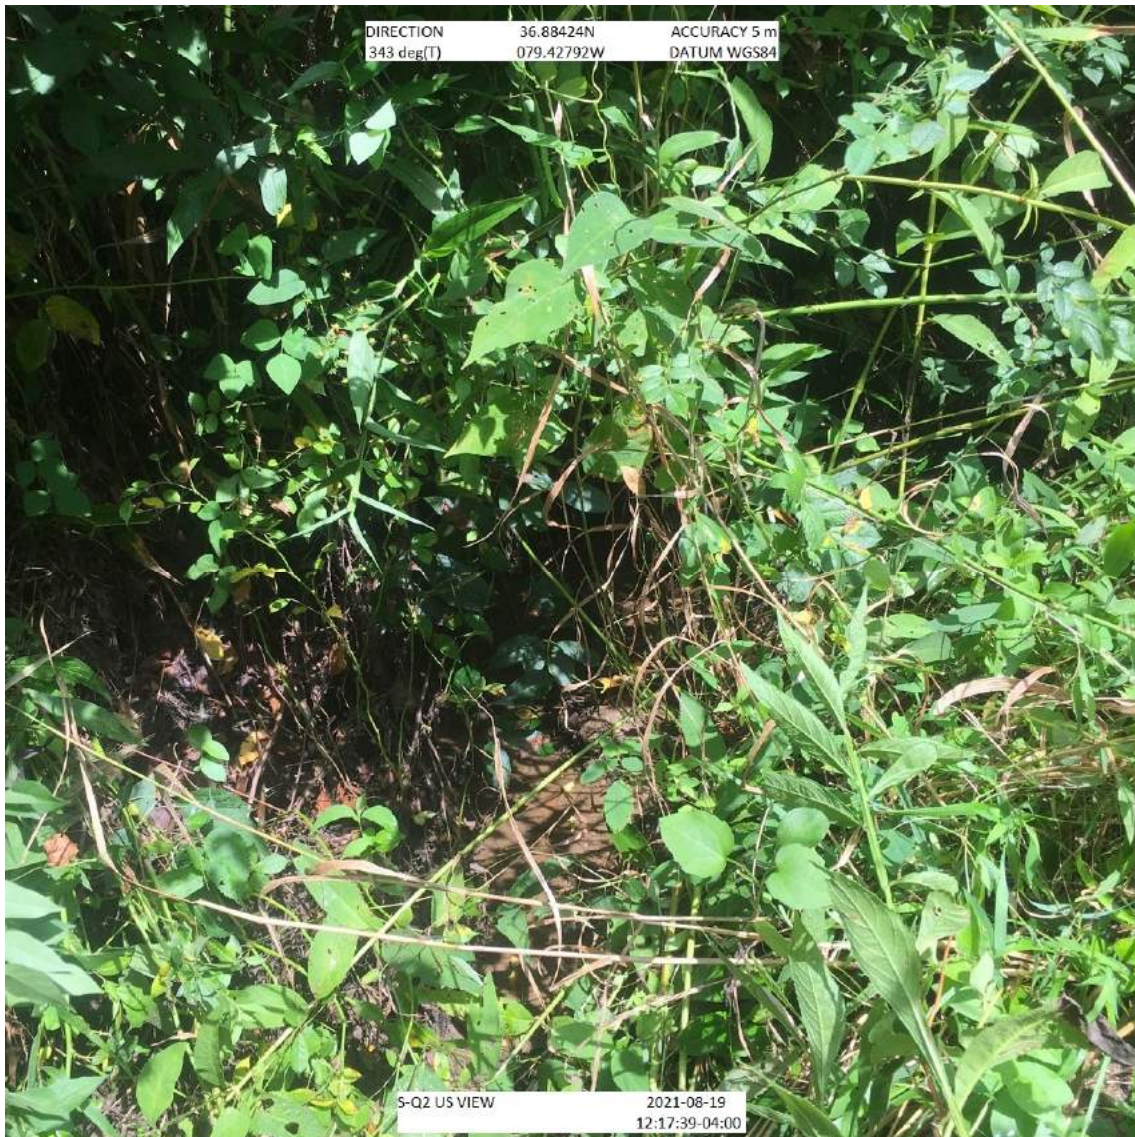
Photo Type: US VIEW

Location, Orientation, Photographer Initials: Upstream view of ROW looking SW, CB/BH

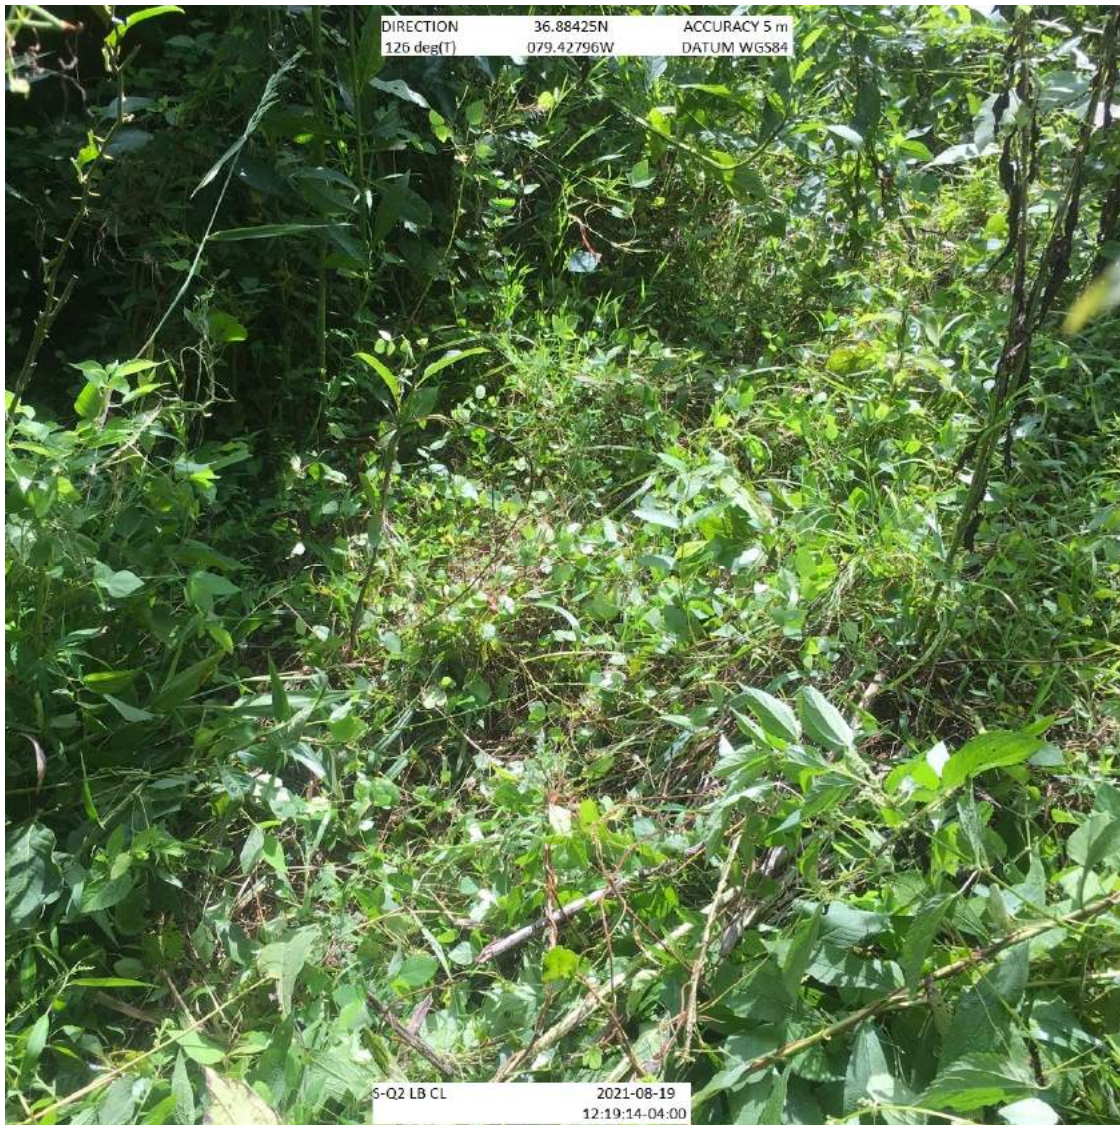
Photo Type: LB CL

Location, Orientation, Photographer Initials: Standing on LB looking at RB along pipe centerline looking N, CB/BH

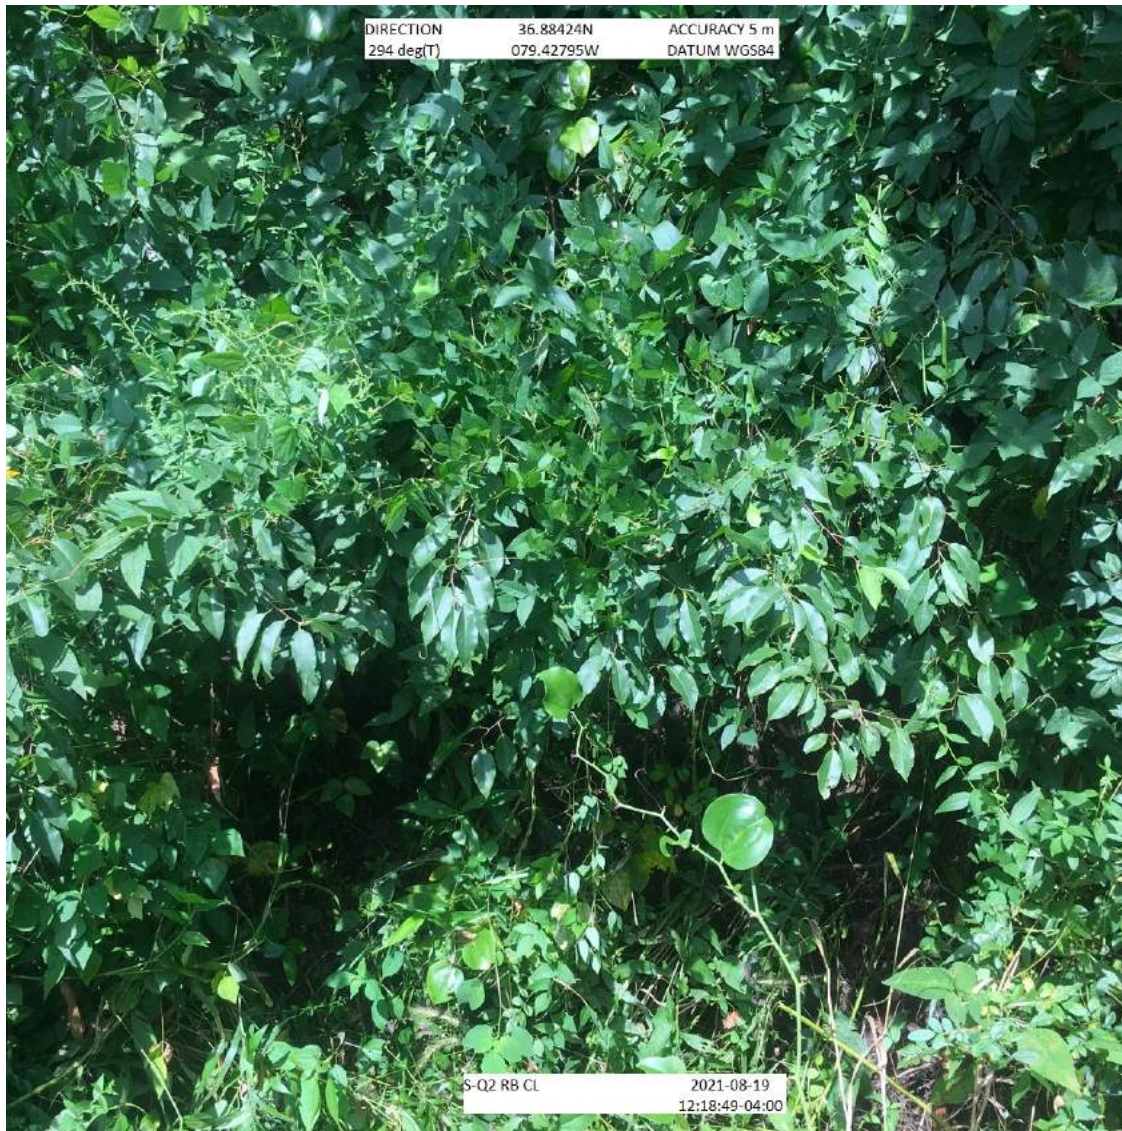
Photo Type: RB CL

Location, Orientation, Photographer Initials: Standing on RB looking at LB along pipe centerline looking N, CB/BH

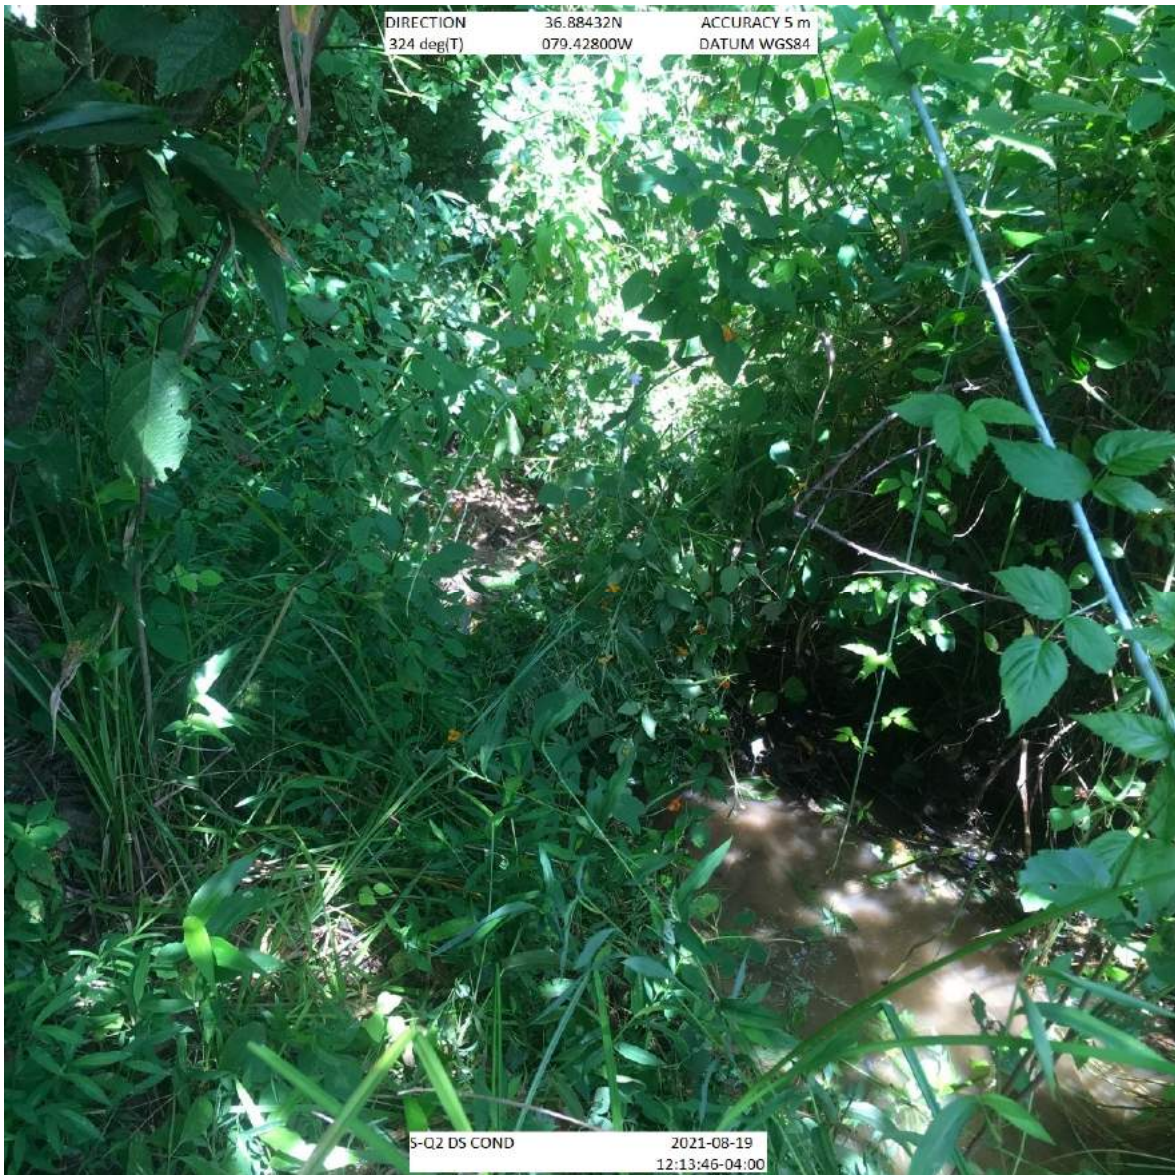
Photo Type: DS COND

Location, Orientation, Photographer Initials: Downstream conditions outside of ROW looking NE, CB/BH
