## Baseline Assessment – Stream Attributes

**Reach S-Q4 (Timber Mat Crossing)**

**Pittsylvania County, Virginia**

Crossing S-Q4- UNT to Pole Bridge Branch (MP 296.1)

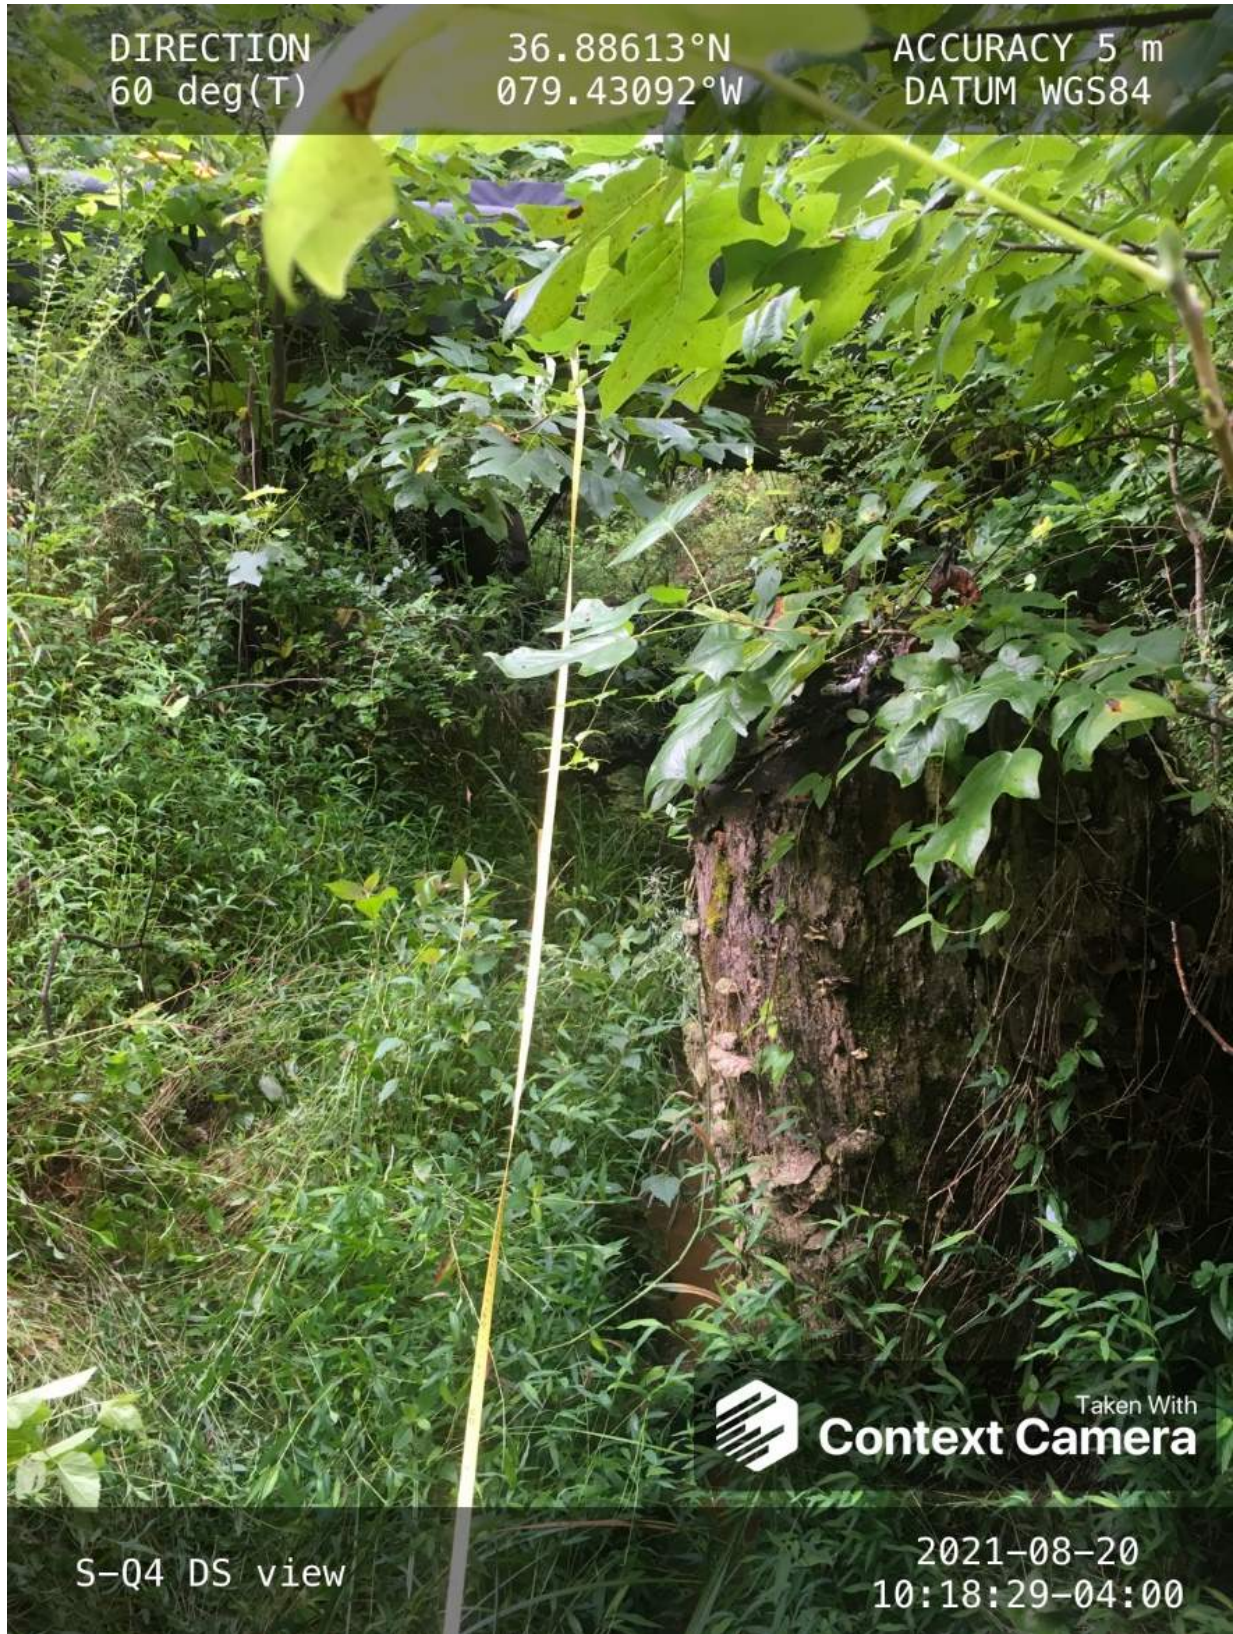
Photo Type: DS VIEW

Location, Orientation, Photographer Initials: Downstream view of ROW looking NE, CB/BH

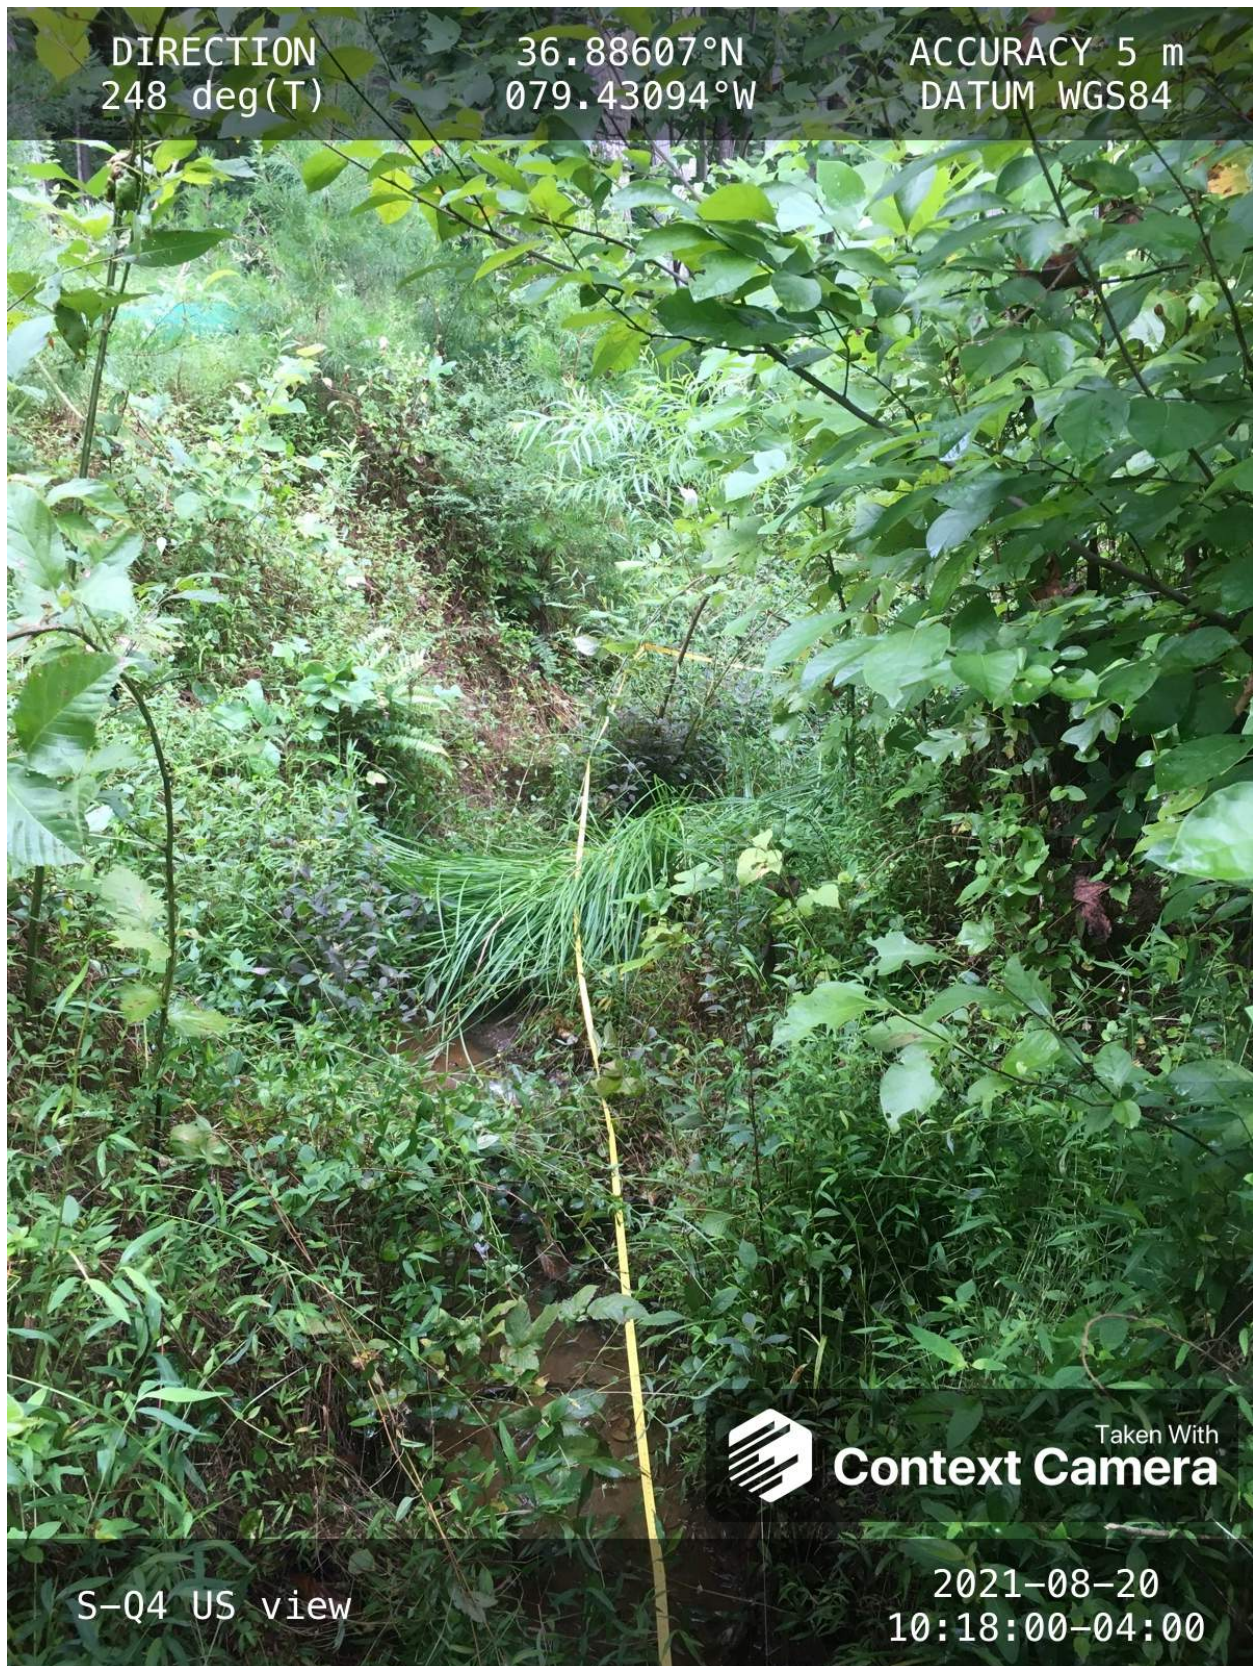
Photo Type: US VIEW  
Location, Orientation, Photographer Initials: Upstream view of ROW looking SW, CB/BH

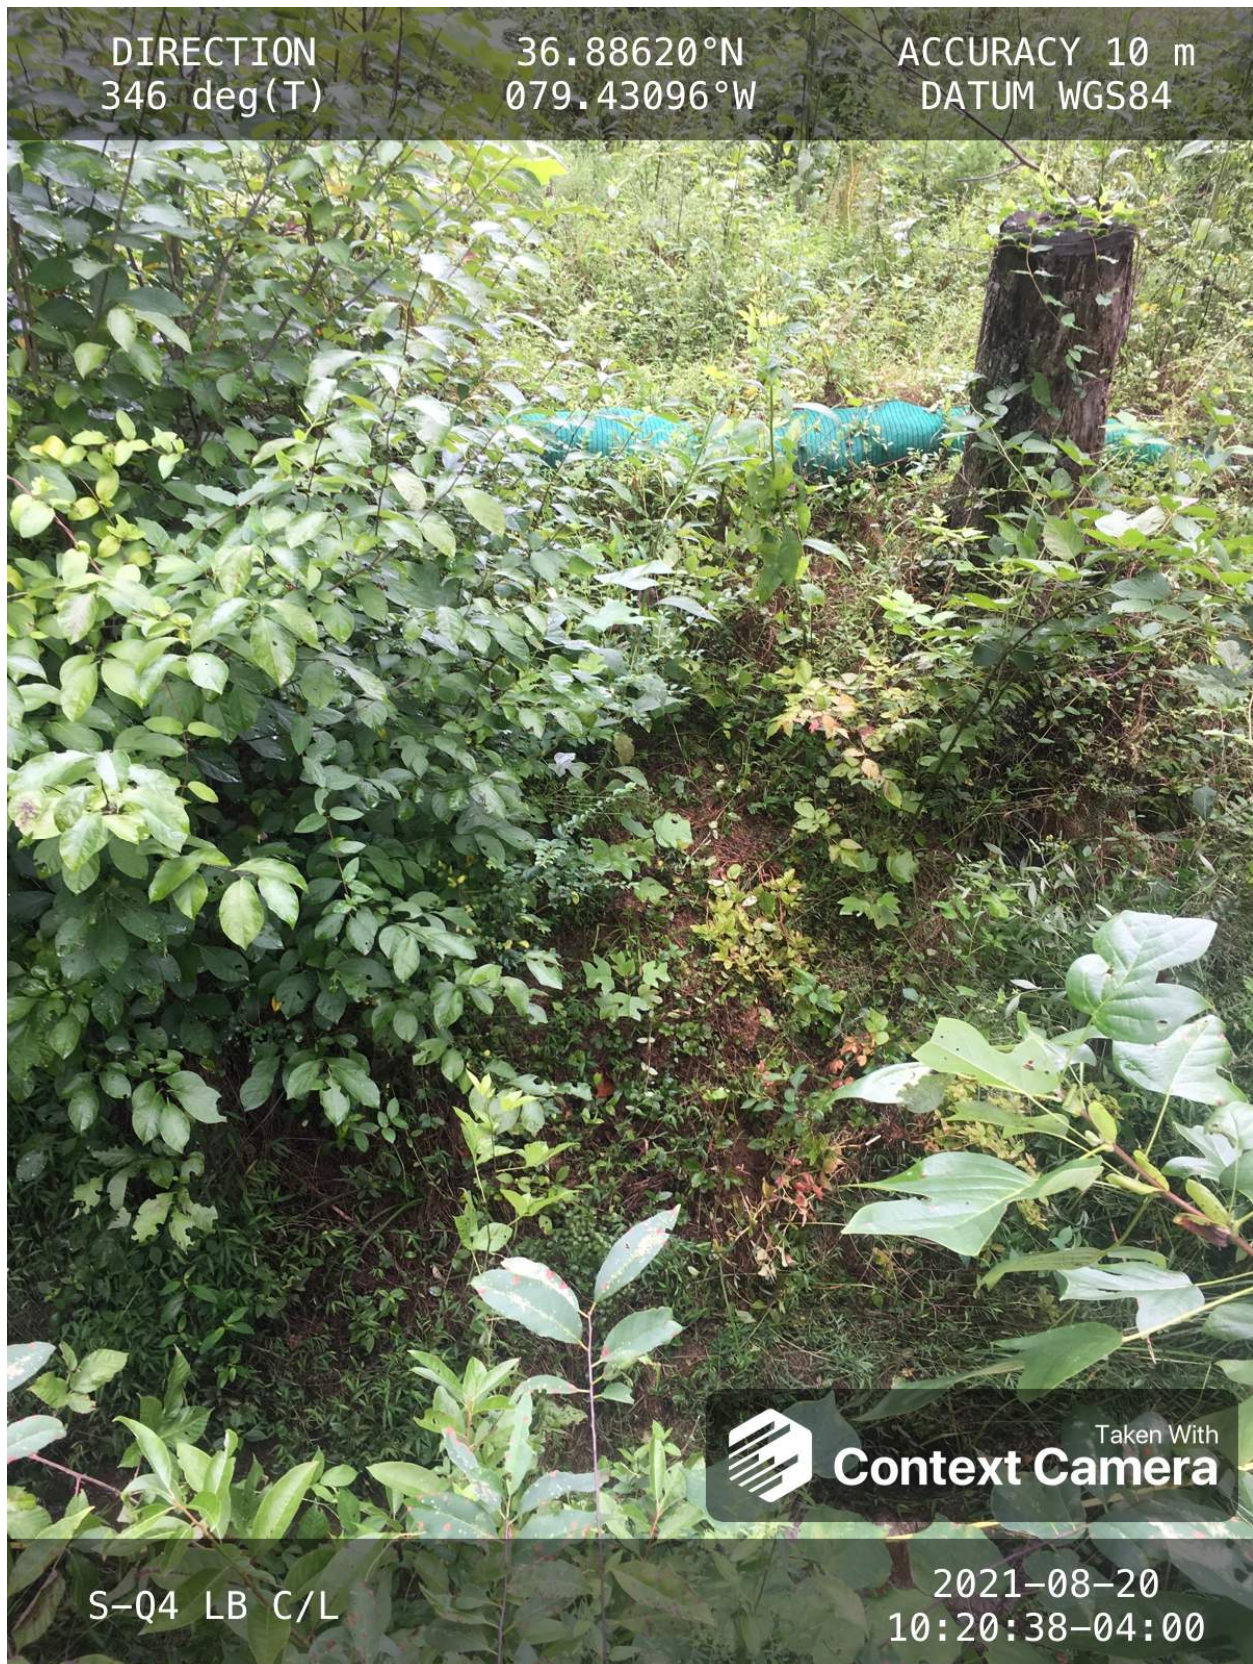
Photo Type: LB CL

Location, Orientation, Photographer Initials: Standing on LB looking at RB along pipe centerline looking N, CB/BH

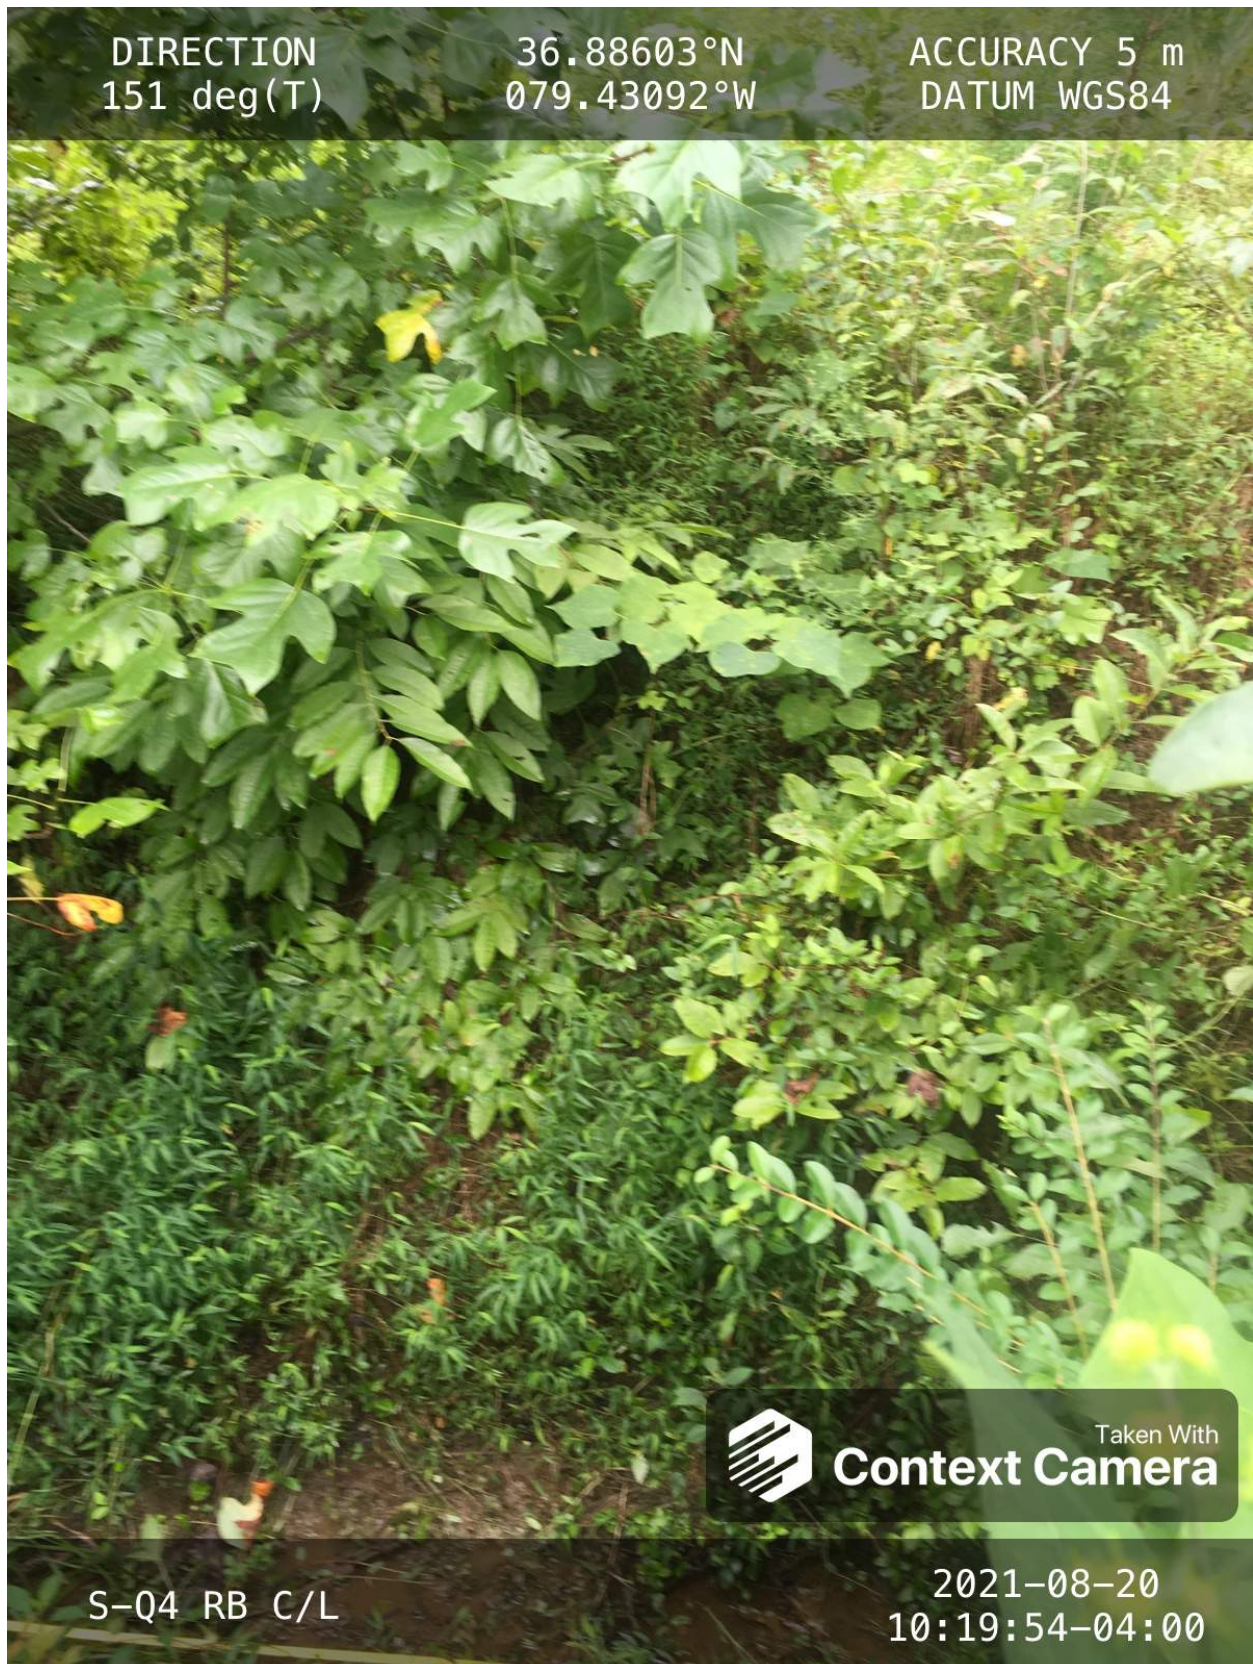
Photo Type: RB CL

Location, Orientation, Photographer Initials: Standing on RB looking at LB along pipe centerline looking N, CB/BH

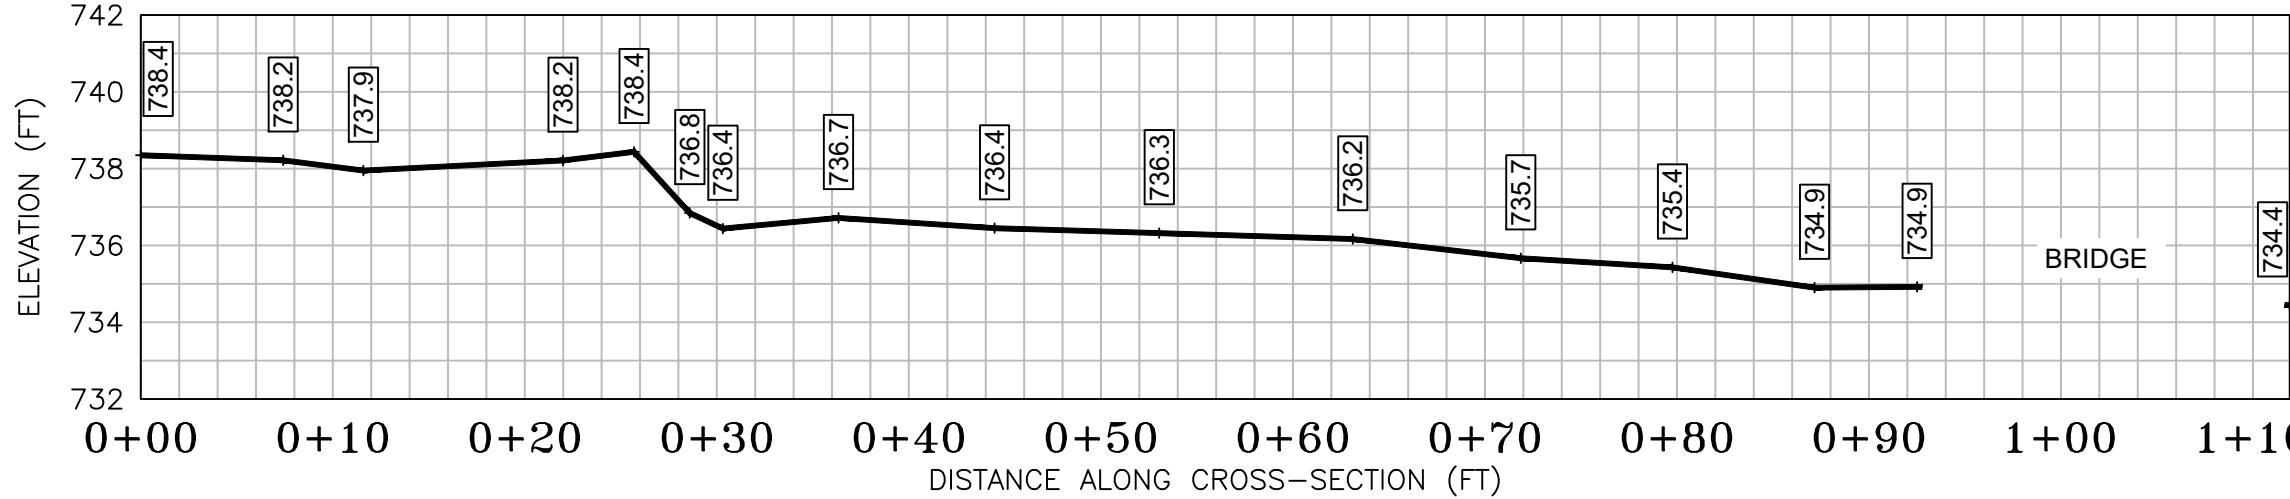
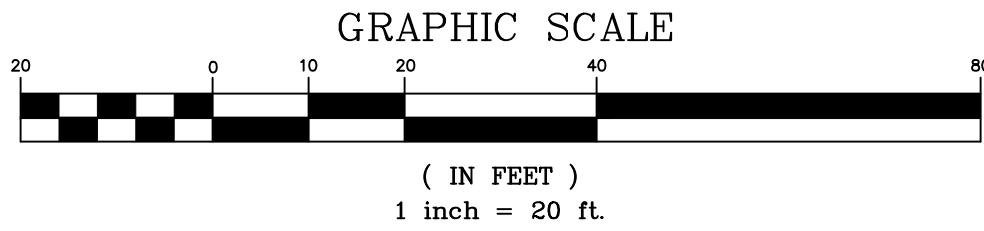
CL TAKEOUT POINTS: S-Q4 CROSS SECTION B (PIPE CL)				
	PRE-CROSSING			POST-CROSSING
PT. LOC.	NORTHING	EASTING	ELEV	
TS-L	13396899.50	2099168.84	740.69	----
BS-L	13396904.24	2099165.86	736.37	----
THW	13396905.85	2099164.78	735.67	----
BS-R	13396907.14	2099163.77	736.08	----
TS-R	13396912.39	2099160.62	740.37	----

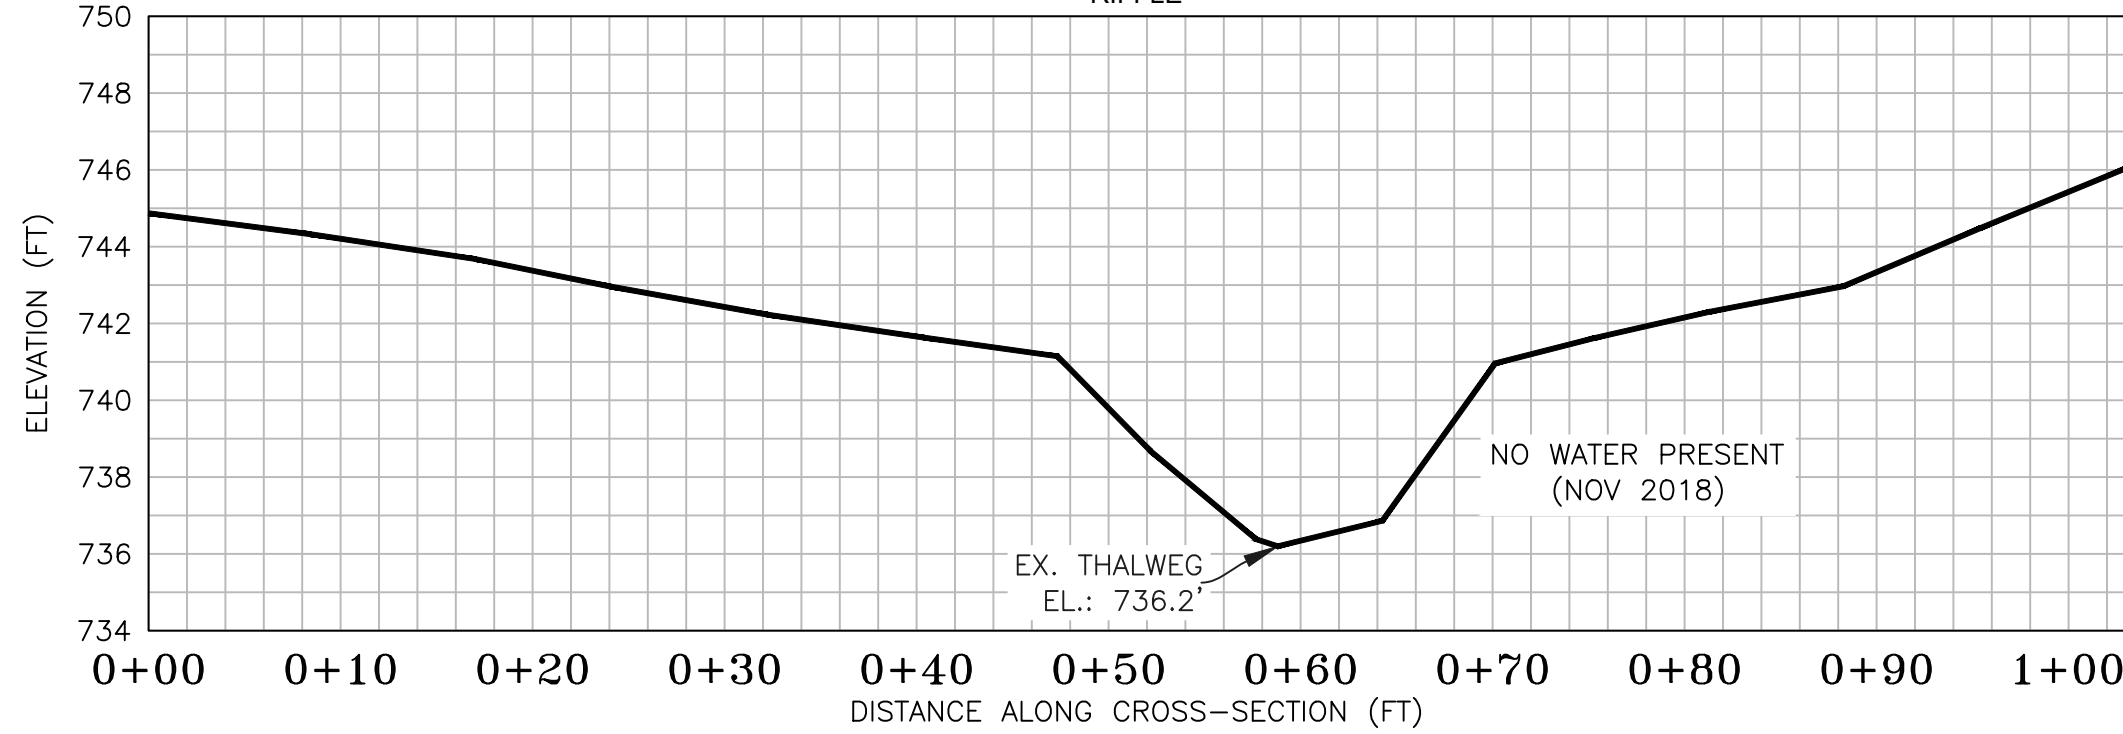
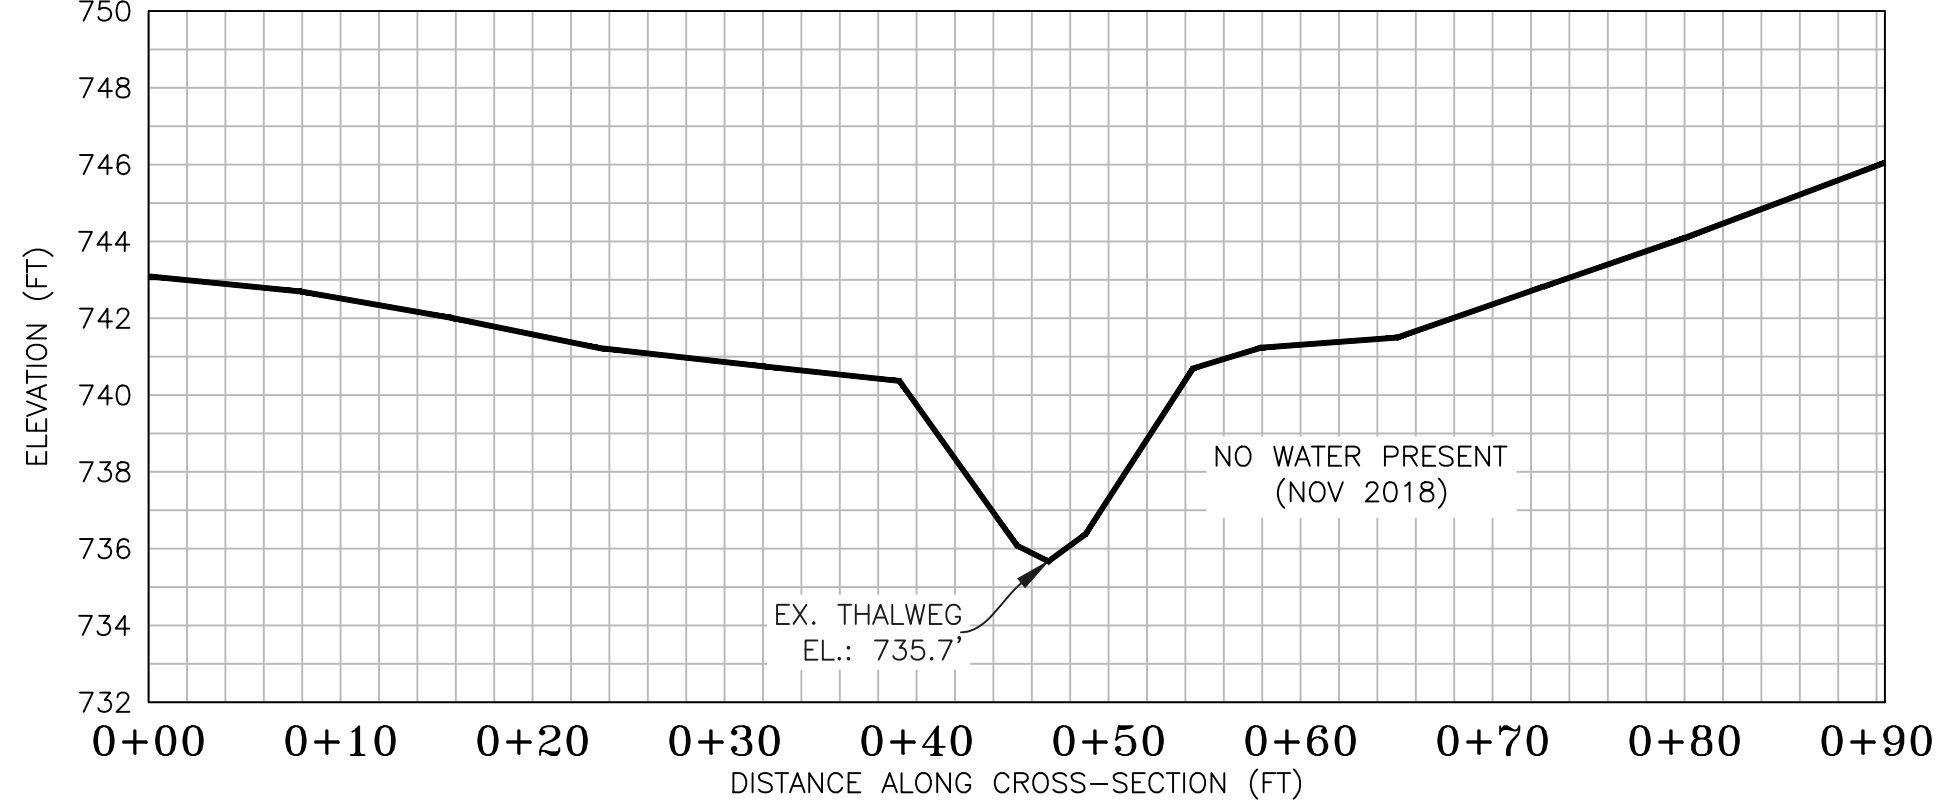
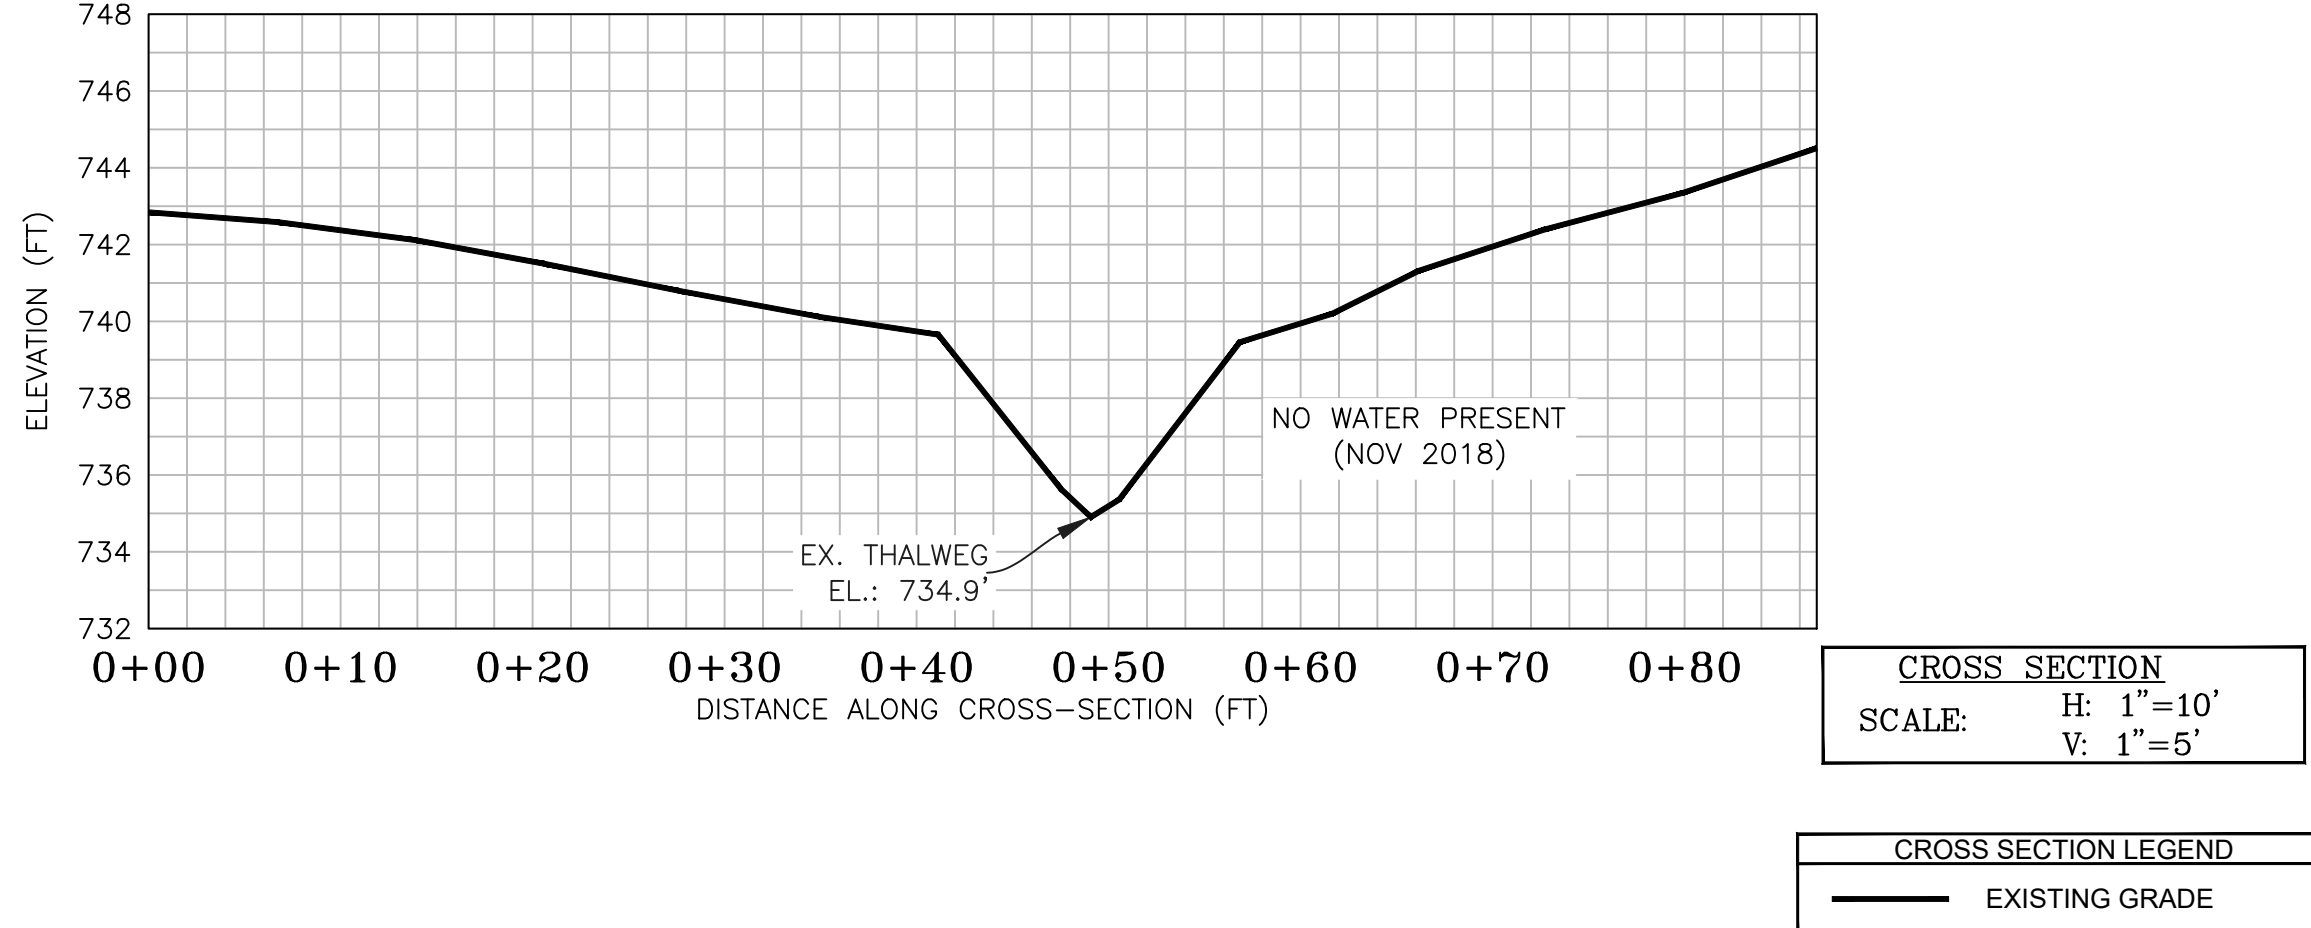
1. This map has been oriented to NAD 1983 UTM ZONE 17N, and vertically to The North American Vertical Datum of 1988 (NAVD 88), using a Real Time Network (RTN) GPS. Field locations were completed on November 1, 2018.
2. Monumentation, including traverse stations and fly points, shown on this drawing should be used to orient any future boundary, topographic, or location survey.
3. Easement lines shown on plan view were provided by Mountain Valley Pipeline (MVP).
4. WSSI Contour Interval = 2.0'. Contours within the channel were interpolated using stream channel breaklines (i.e. top of slopes, toe of slopes, thalweg) and cross-sectional points. Contours outside the channel were interpolated using cross-sectional spot shots.
5. All section views shown are left to right facing downstream.
6. Cross-section B shot at location of pipe centerline (based on best professional judgement).

NOTE: ALL SECTION VIEWS SHOWN LEFT TO RIGHT FACING DOWNSTREAM.
