## Baseline Assessment – Stream Attributes

### Reach S-RR15 (Timber Mat Crossing) Perennial Spread I Franklin County, Virginia

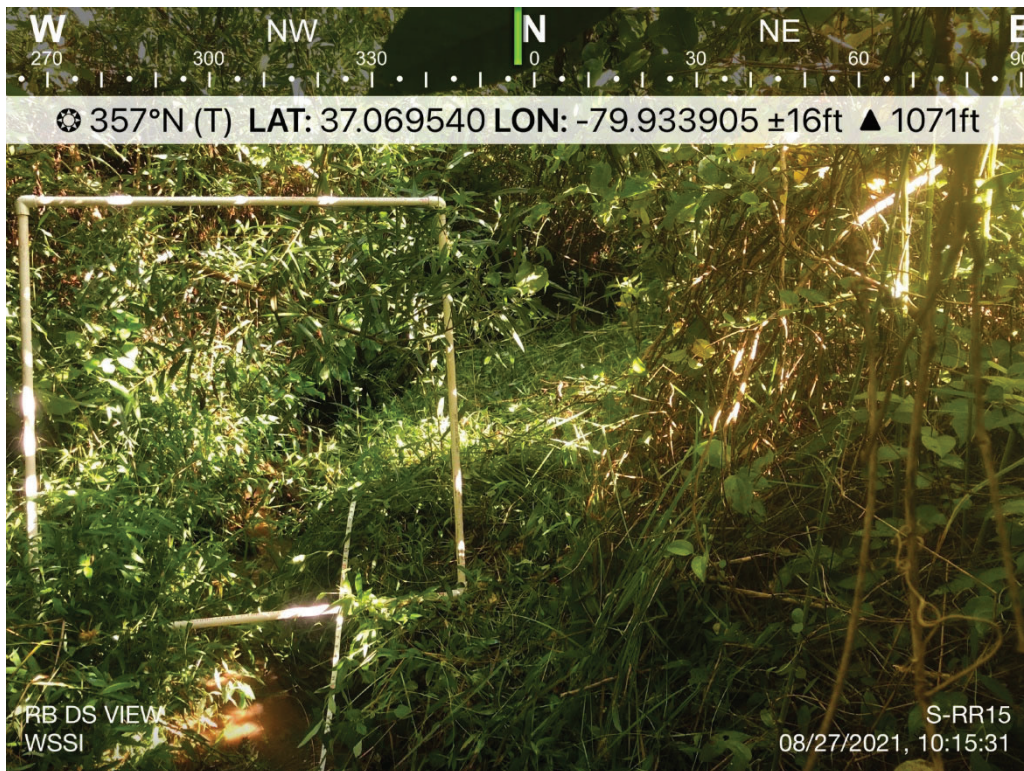
Photo Type: RB DS VIEW

Location, Orientation, Photographer Initials: Standing on RB looking downstream along the LOD looking N, AO

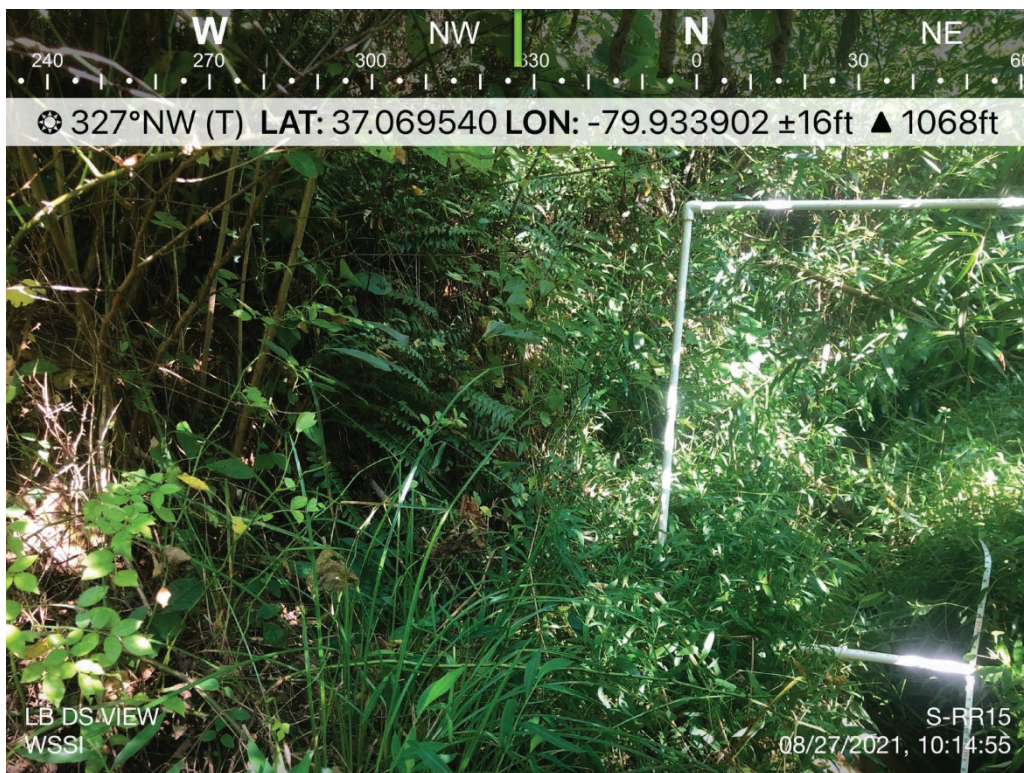
Photo Type: LB DS VIEW

Location, Orientation, Photographer Initials: Standing on LB looking downstream along the LOD looking NW, AO

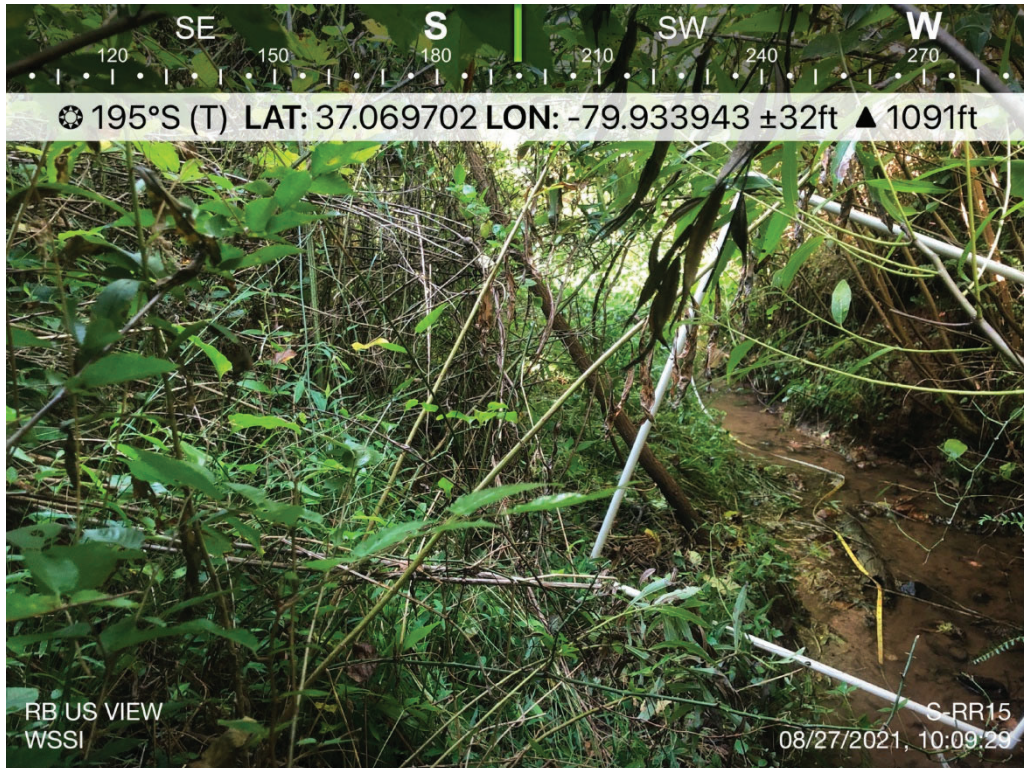
Photo Type: RB US VIEW

Location, Orientation, Photographer Initials: Standing on RB looking upstream along the LOD looking S, AO

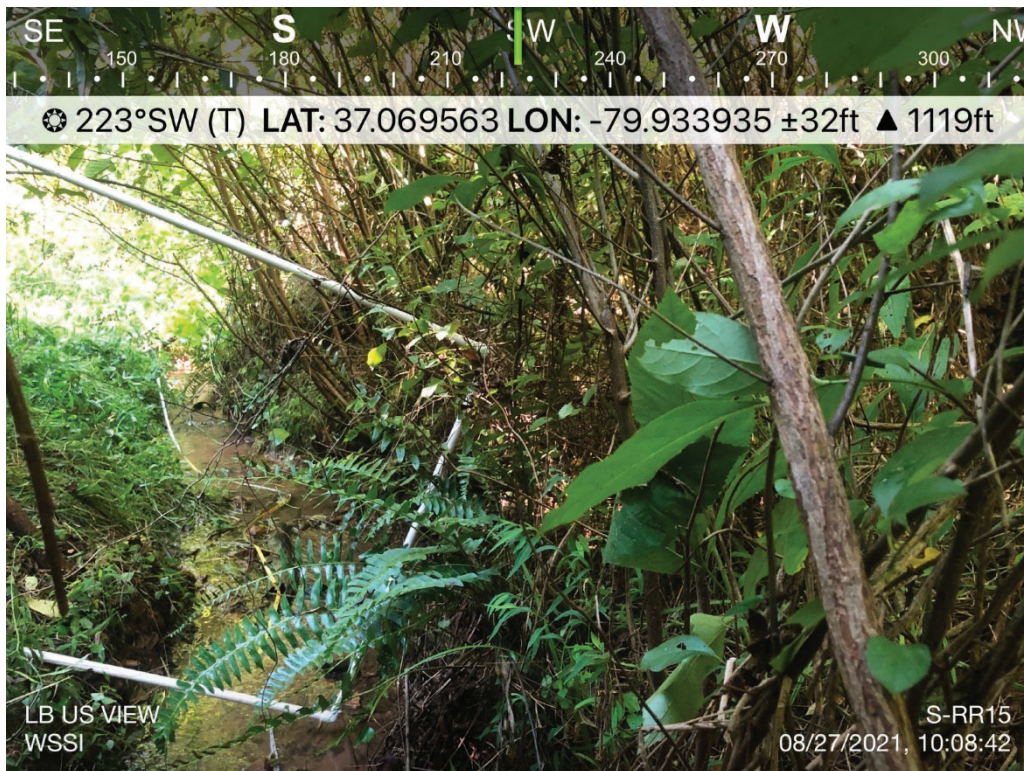
Photo Type: LB US VIEW

Location, Orientation, Photographer Initials: Standing on LB looking upstream along the LOD looking SW, AO

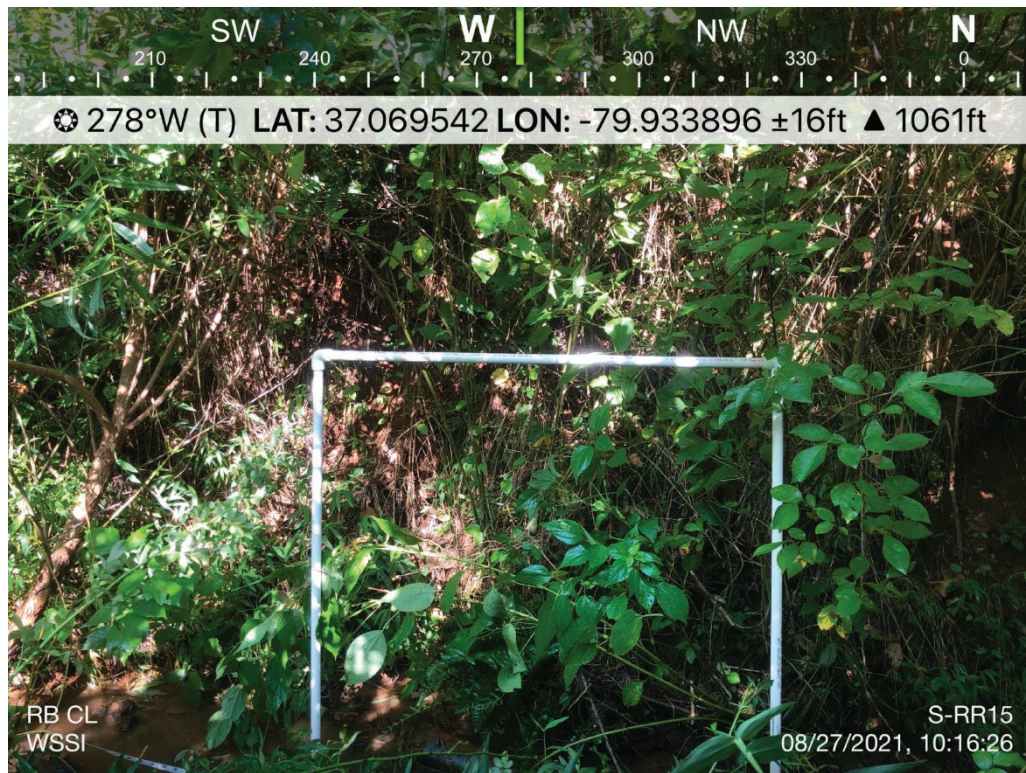
Photo Type: RB CL

Location, Orientation, Photographer Initials: Standing on RB looking at LB along pipe centerline looking W, AO

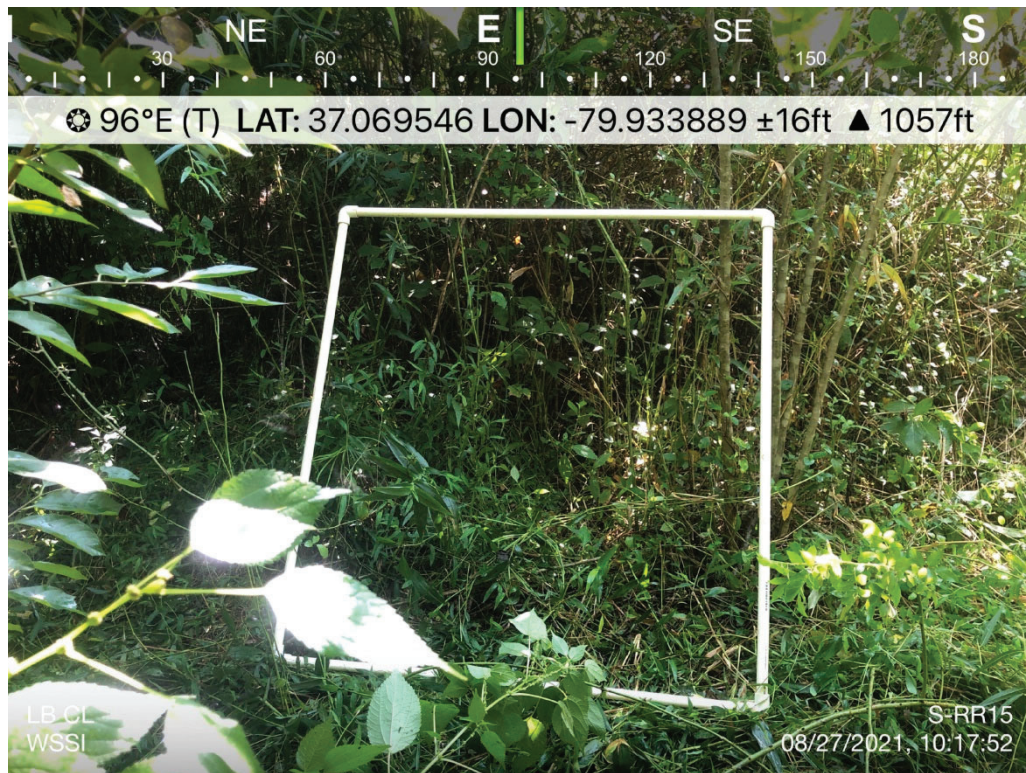
Photo Type: LB CL

Location, Orientation, Photographer Initials: Standing on LB looking at RB along pipe centerline looking E, AO

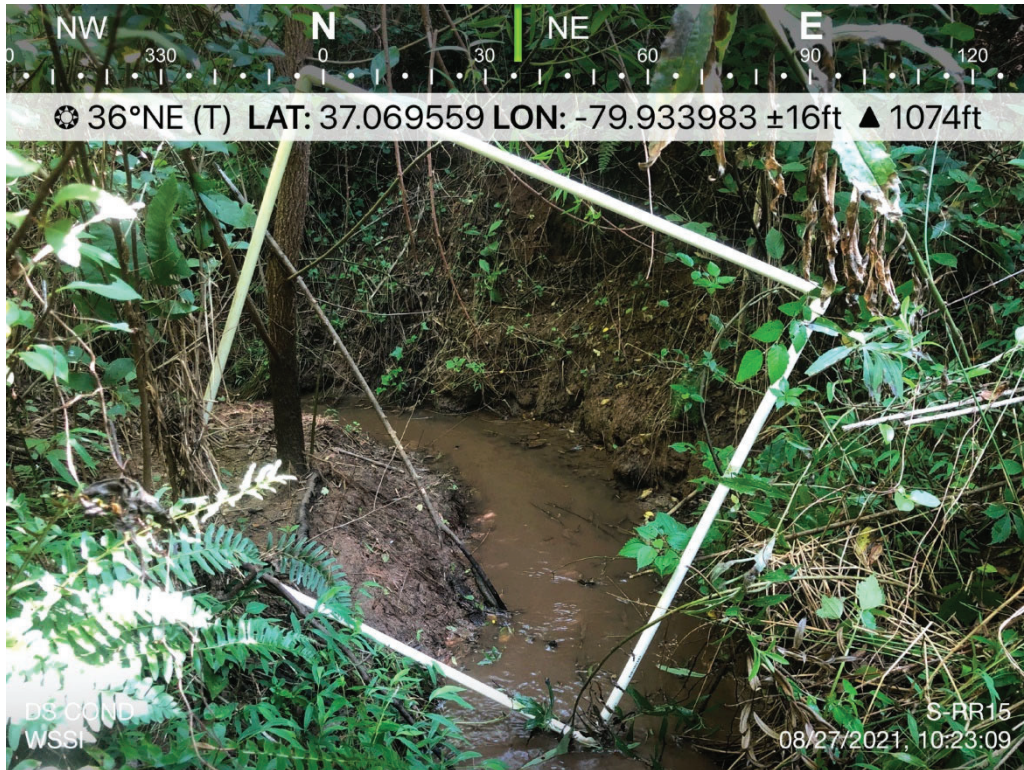
Photo Type: DS COND

Location, Orientation, Photographer Initials: Downstream conditions outside of LOD looking NE, AO

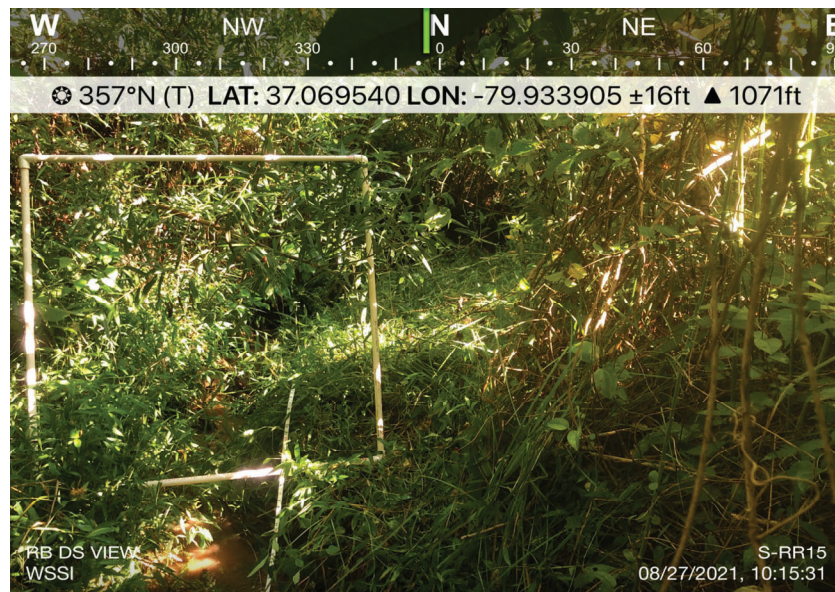
Downstream view of S-RR18 from the right bank facing N in the ROW. Assessment is limited to areas within the temporary ROW.
