Baseline Assessment – Stream Attributes

Reach S-SS8 (Timber Mat Crossing) Perennial Spread I Franklin County County, Virginia

Profile and Cross-Sections Baseline Survey

Crossing S-SS8 - Polecat Creek (MP 281.1)

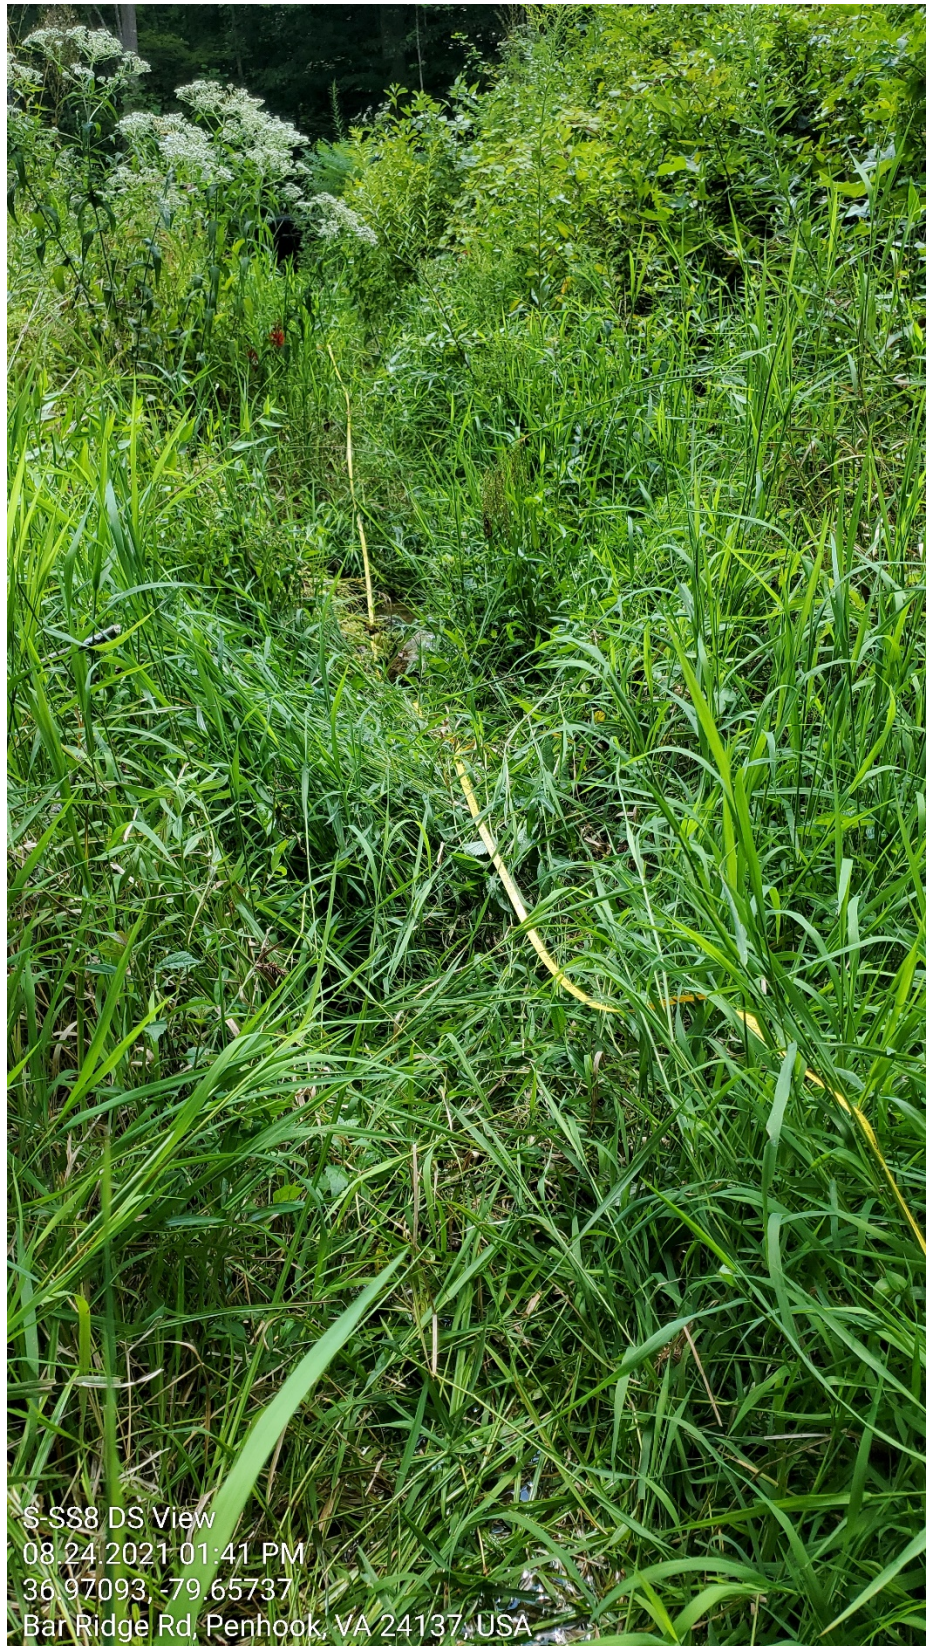
Photo Type: DS VIEW

Location, Orientation, Photographer Initials: Downstream view of ROW/LOD looking S, DW

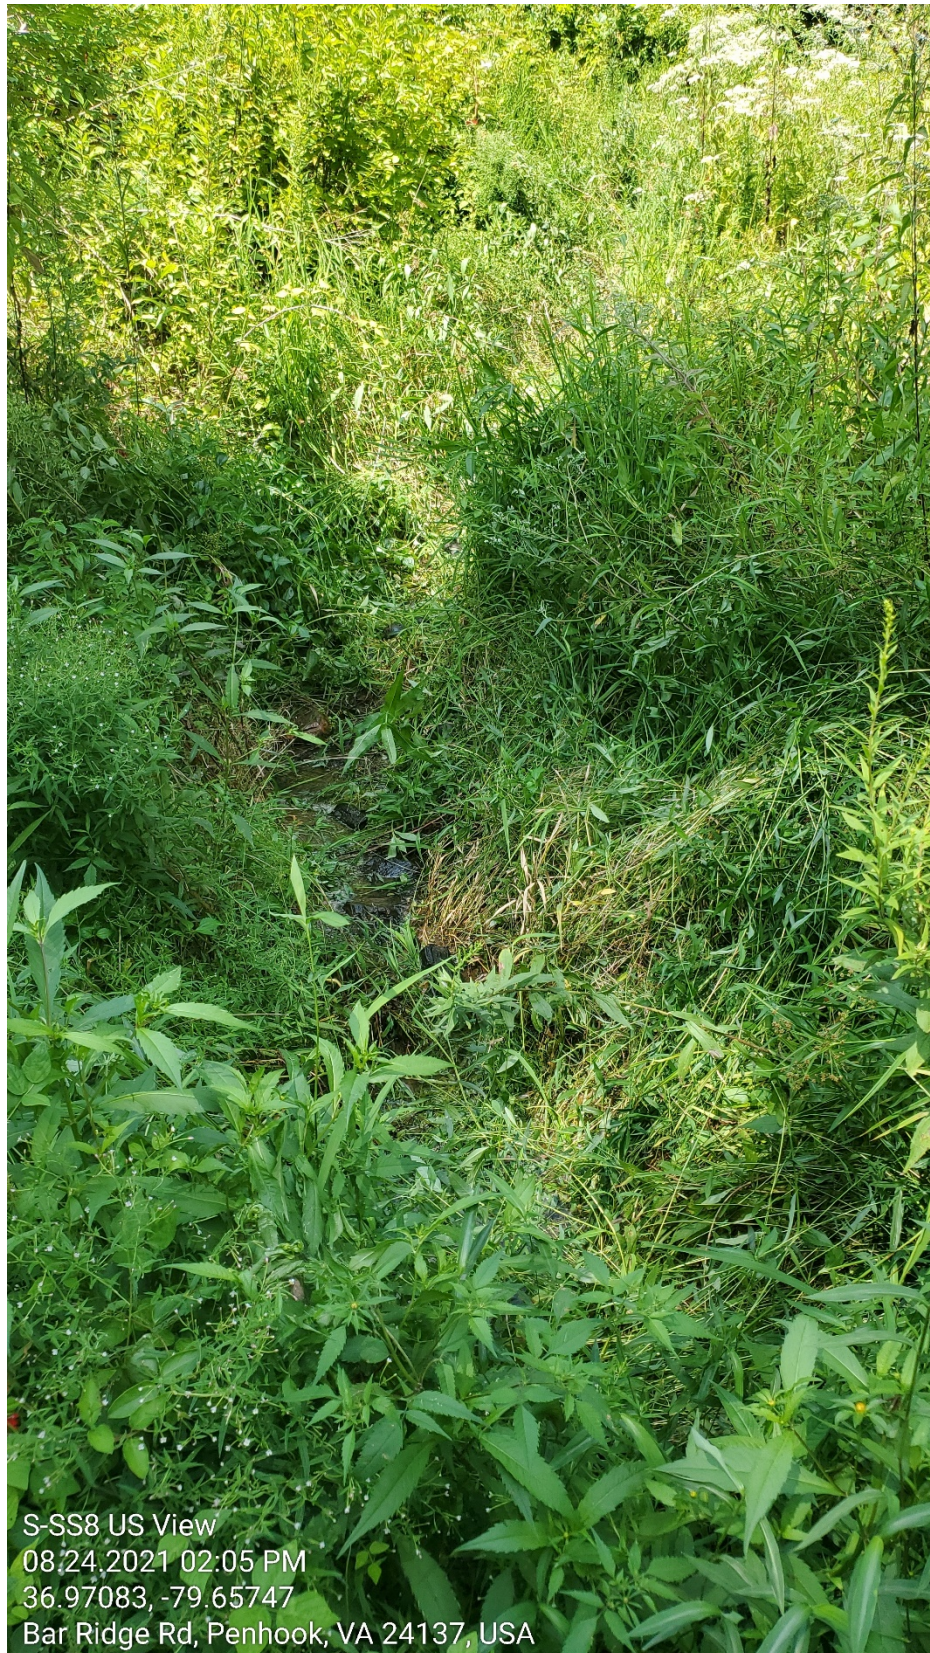
Photo Type: US VIEW

S-SS8 US View
08/24/2021 02:05 PM
36.97083, -79.65747
Bar Ridge Rd, Penhook, VA 24137, USA

Location, Orientation, Photographer Initials: Upstream view of ROW/LOD looking N, Photographer Initials

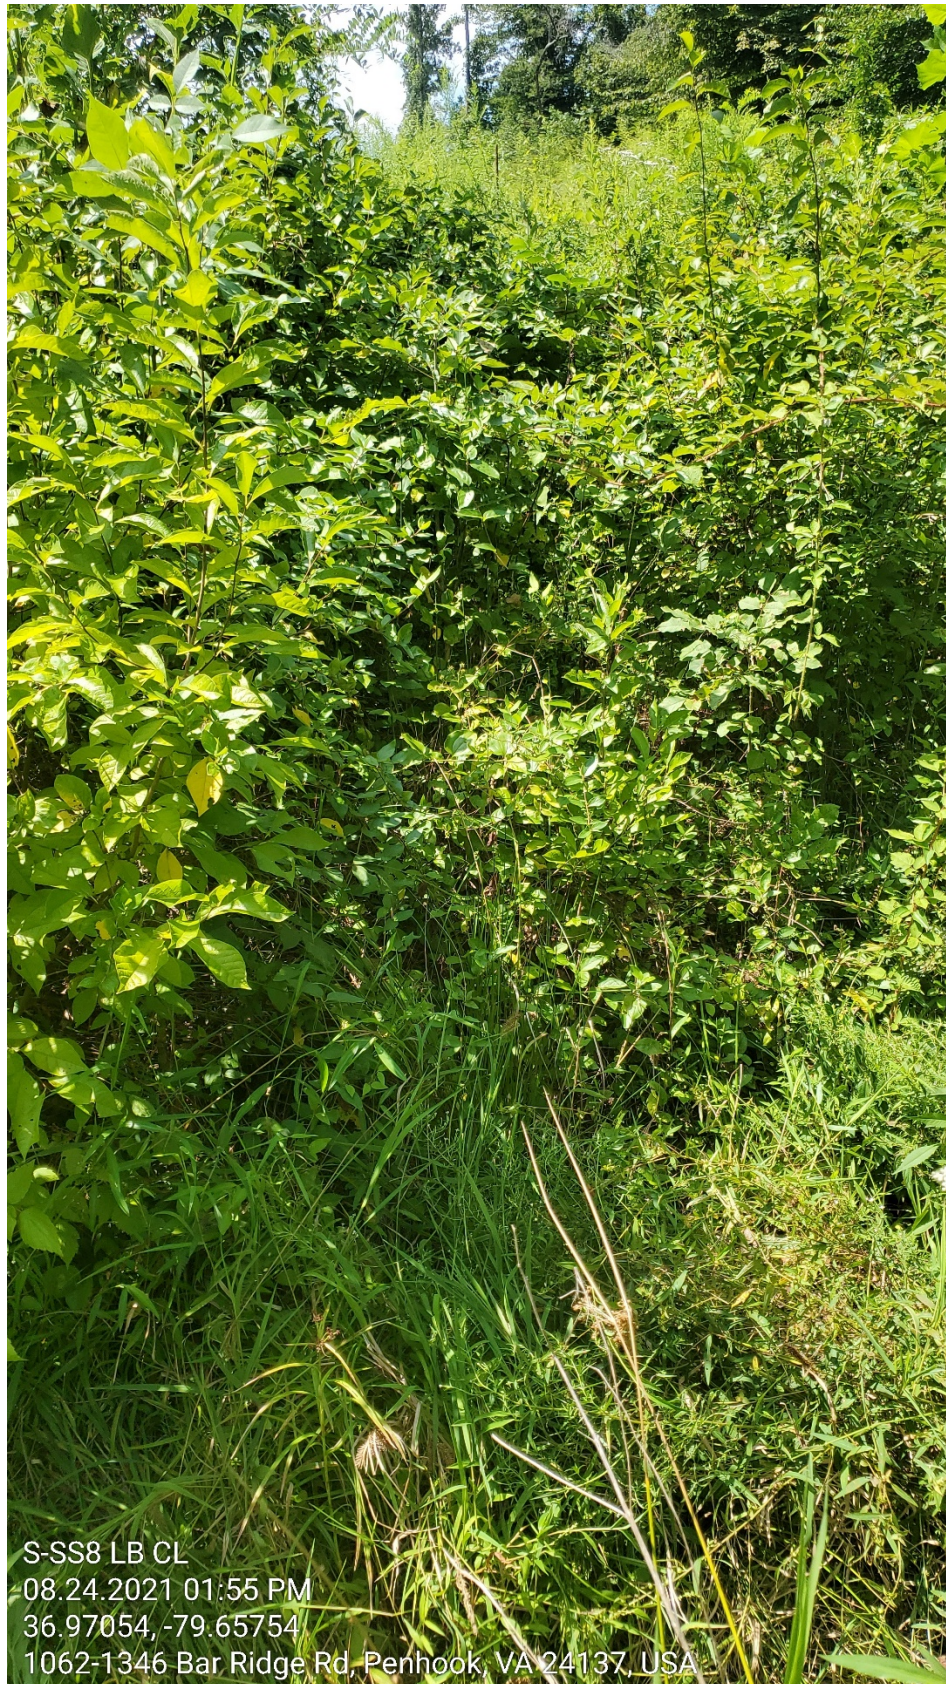
Photo Type: LB CL

Location, Orientation, Photographer Initials: Standing on LB looking at RB along pipe centerline looking W, DW

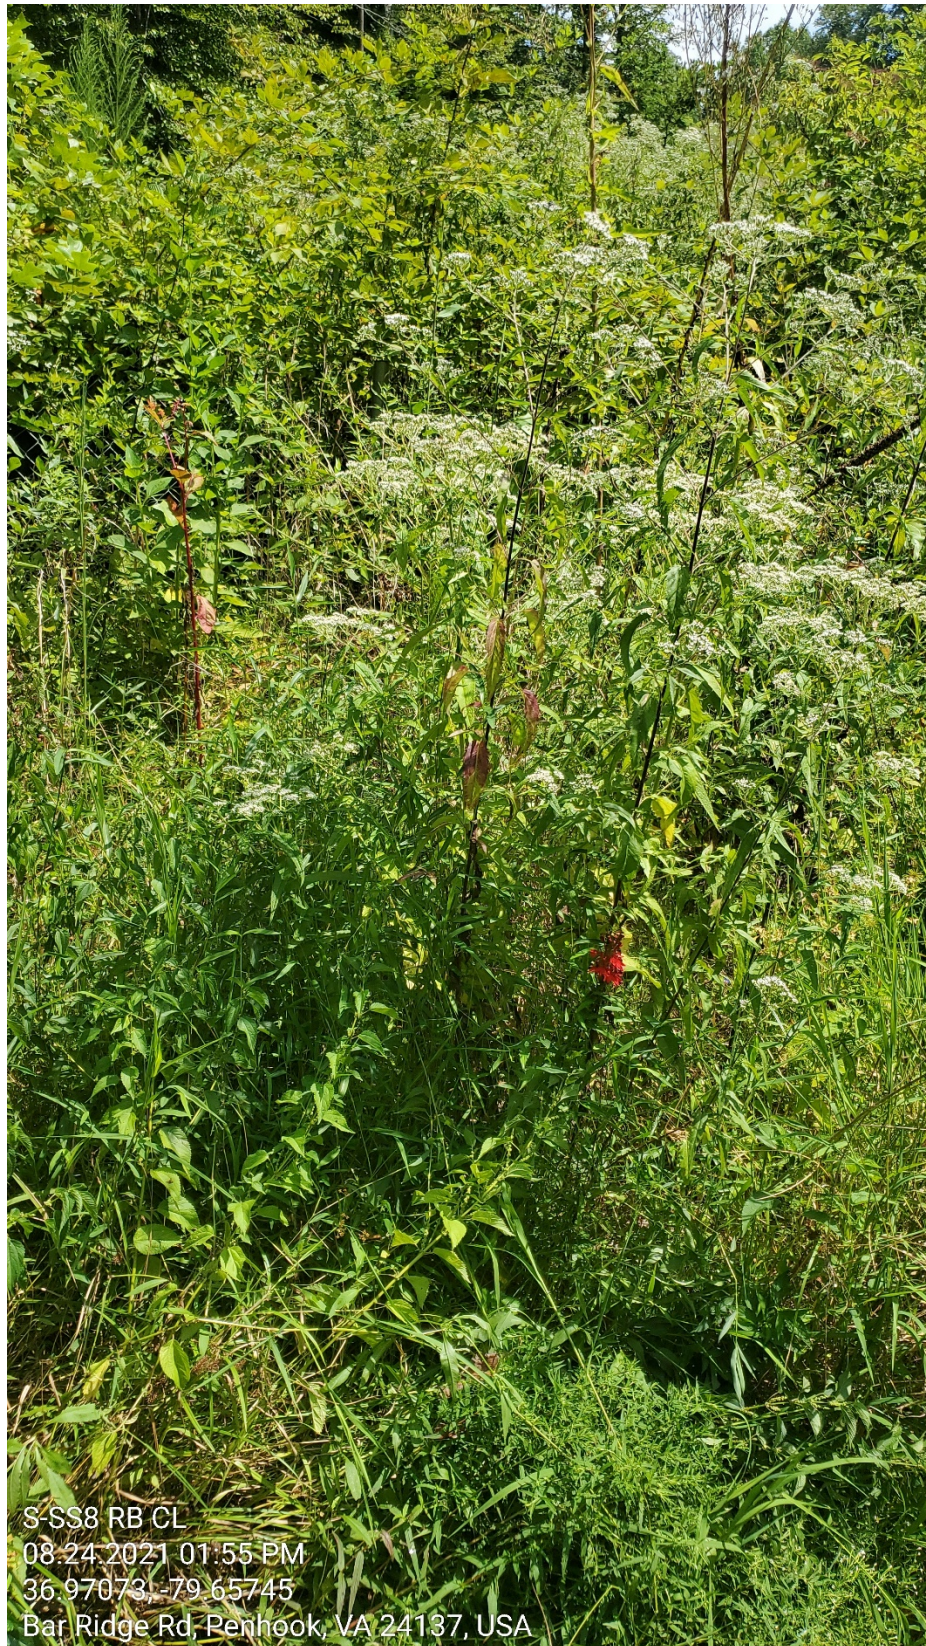
Photo Type: RB CL

Location, Orientation, Photographer Initials: Standing on RB looking at LB along pipe centerline looking E, DW

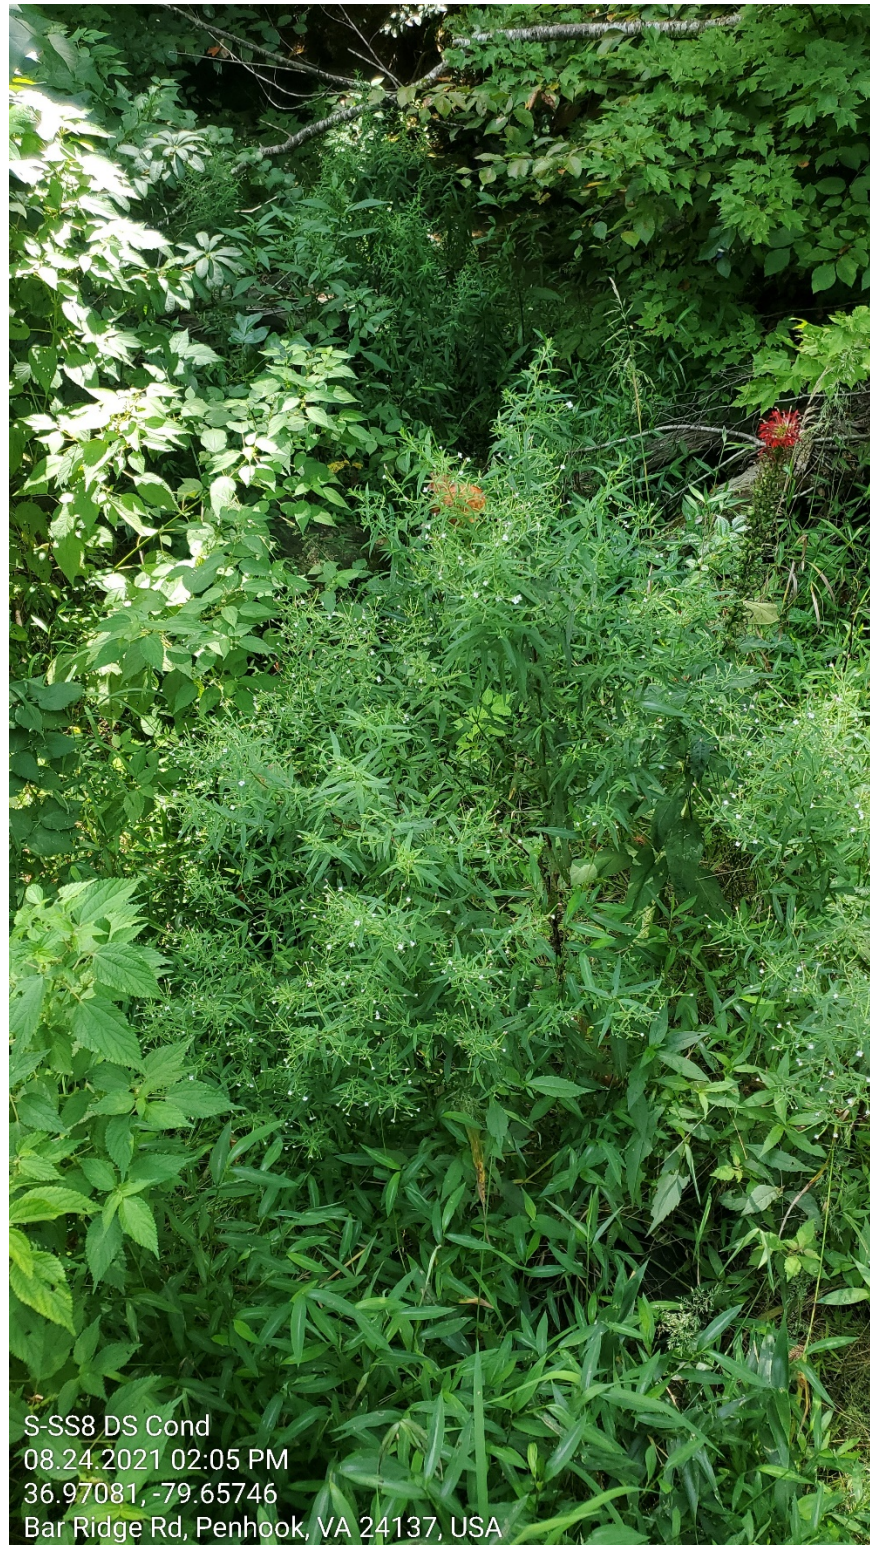
Photo Type: DS COND

S-SS8 DS Cond
08.24.2021 02:05 PM
36.97081, -79.65746
Bar Ridge Rd, Penhook, VA 24137, USA

Location, Orientation, Photographer Initials: Downstream conditions outside of ROW/LOD looking S, DW

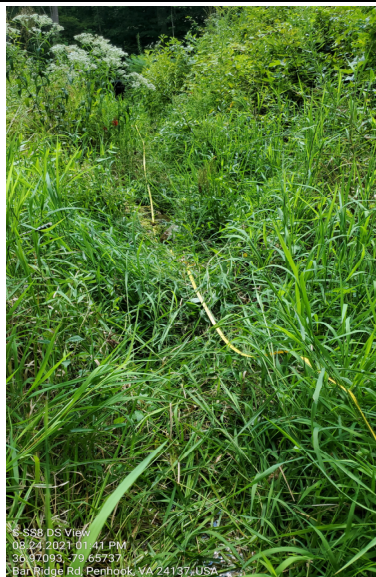
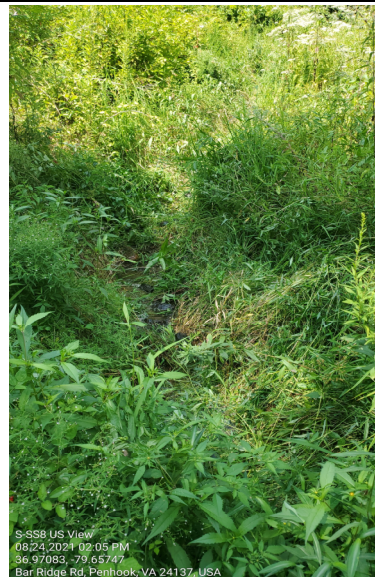
INSERT PHOTOS:

CAPTION. Assessment is limited to areas within the temporary ROW.
